TEST REPORT FOR:

Virginia Department of Transportation
SKT SP 350 50' (15.24 m) System

TR-P36067-01-NC

Test Article: SKT SP 350 50' (15.24 m) System Project No. P36067-01
 Test Program: 100 km/h 5° Guardrail Terminal Impact Test Test Date: 06/30/16

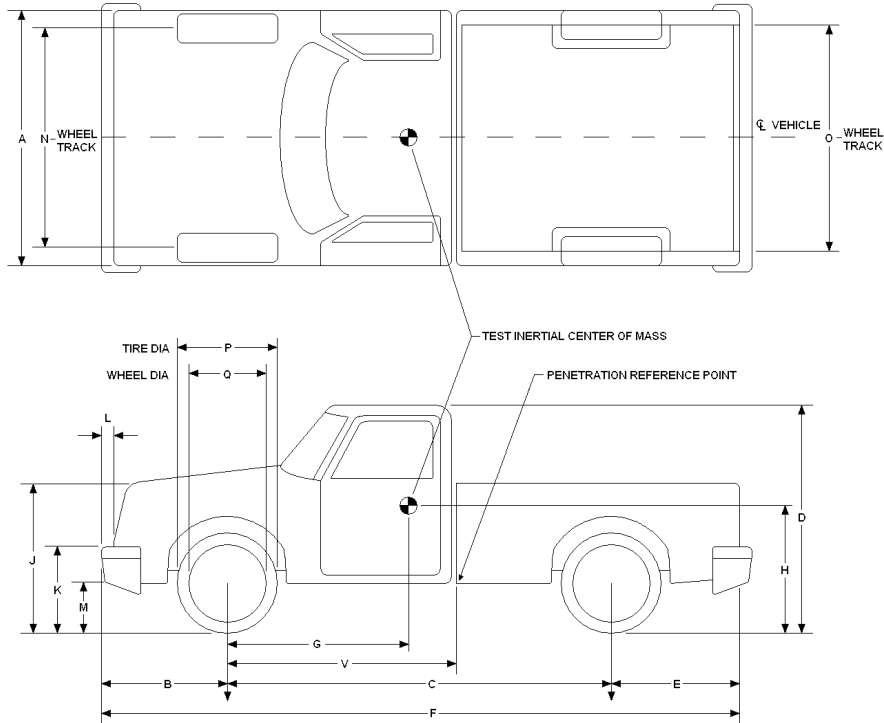
DATA SHEET 2

TEST VEHICLE GEOMETRY

The test was conducted on June 30, 2016. The as-tested test inertial weight of the vehicle was 2,042.5 kg (4,502.8 lbs.). The height of the front bumper was 415 mm (16.3 in.) to the lower edge and 605 mm (23.8 in.) to the upper edge. Additional dimensions and test vehicle information are presented in Data Sheets No. 1 and 2.

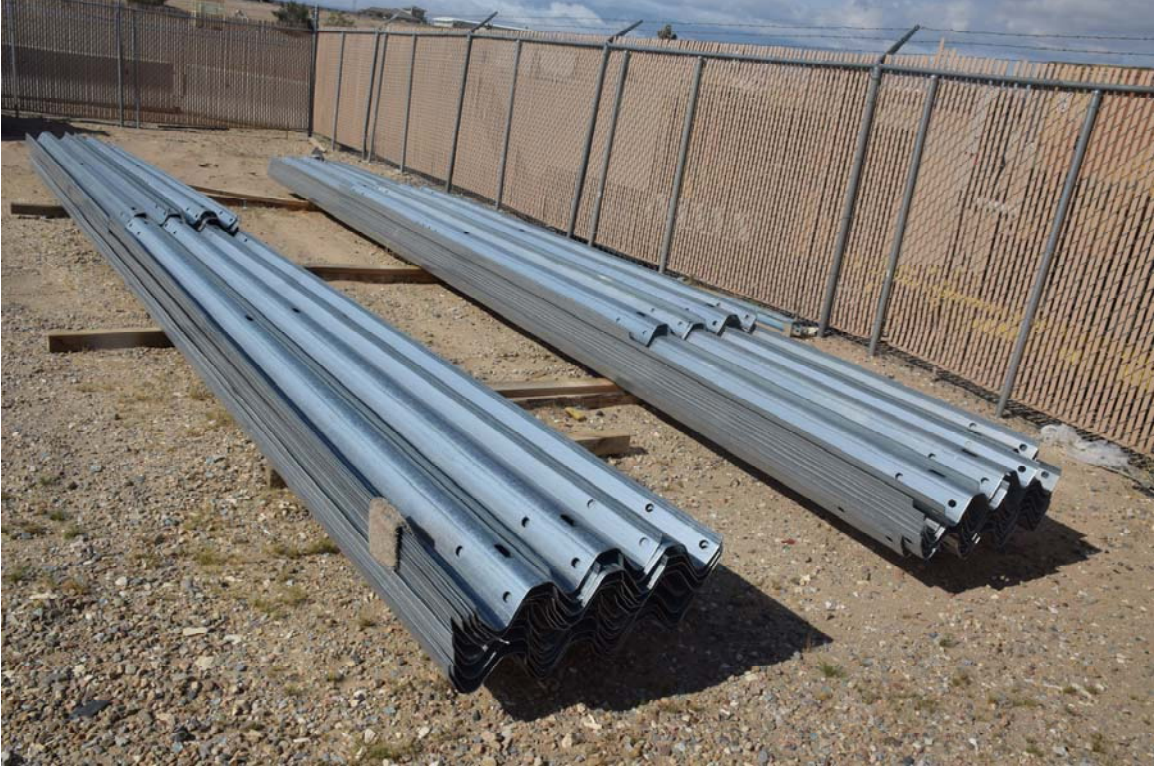
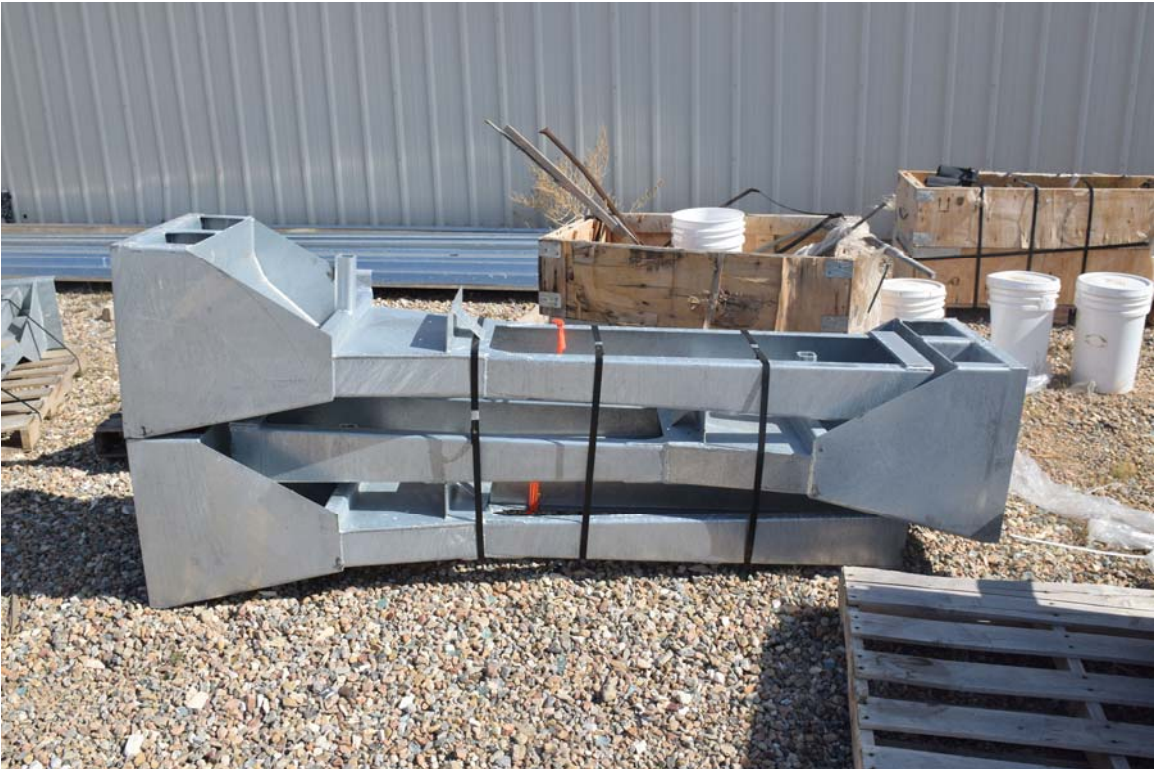
FIGURE 1. Test Article, As Received

FIGURE 2. Test Article, As Received

The Road Systems, Inc. SKT SP 350 50' (15.24 m) System is a standard post guardrail terminal/end treatment. The as-tested SKT SP 350 50' (15.24 m) System consisted of one (1) SKT impact head, two (2) hinged posts, seven (7) standard I-beam line posts, two (2) W-beam rail panels, and one (1) cable anchor assembly. The terminal section was installed with a 50:1 flare and a rail height ranging from 705 mm (27.75 in.) to 730 mm (28.75 in.) per Virginia Department of Transportation (VDOT) Road and Bridge Standards.

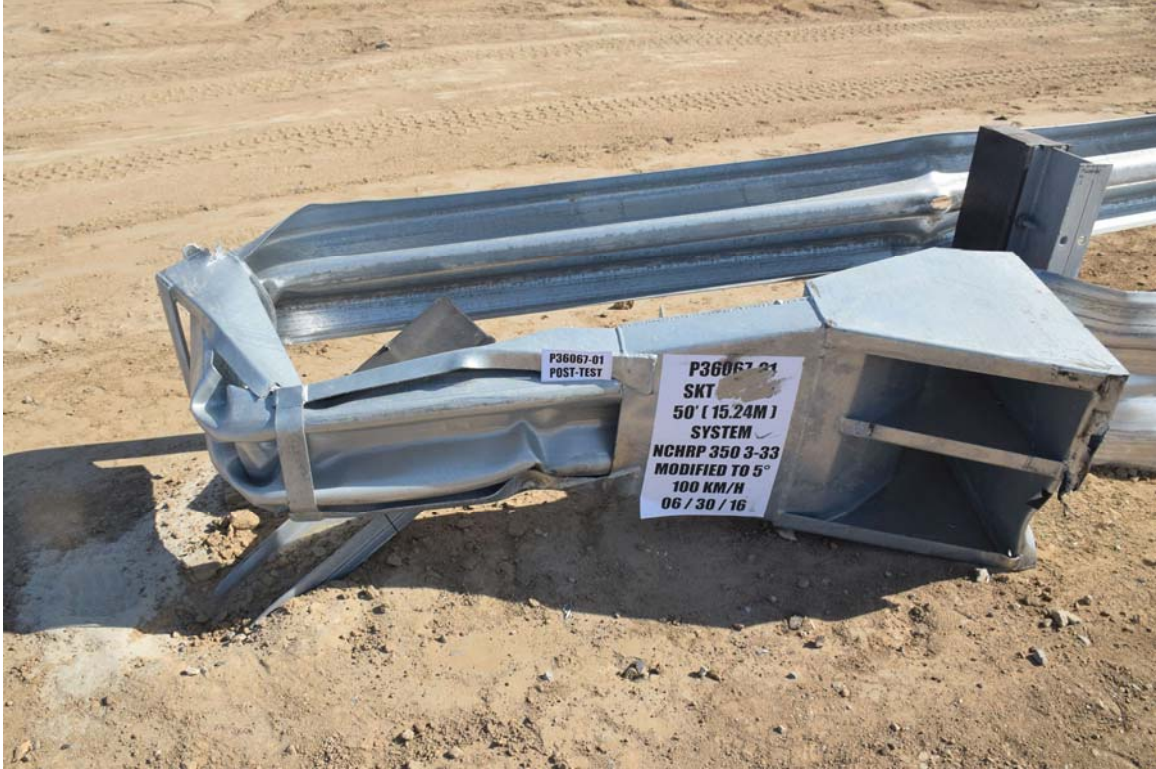
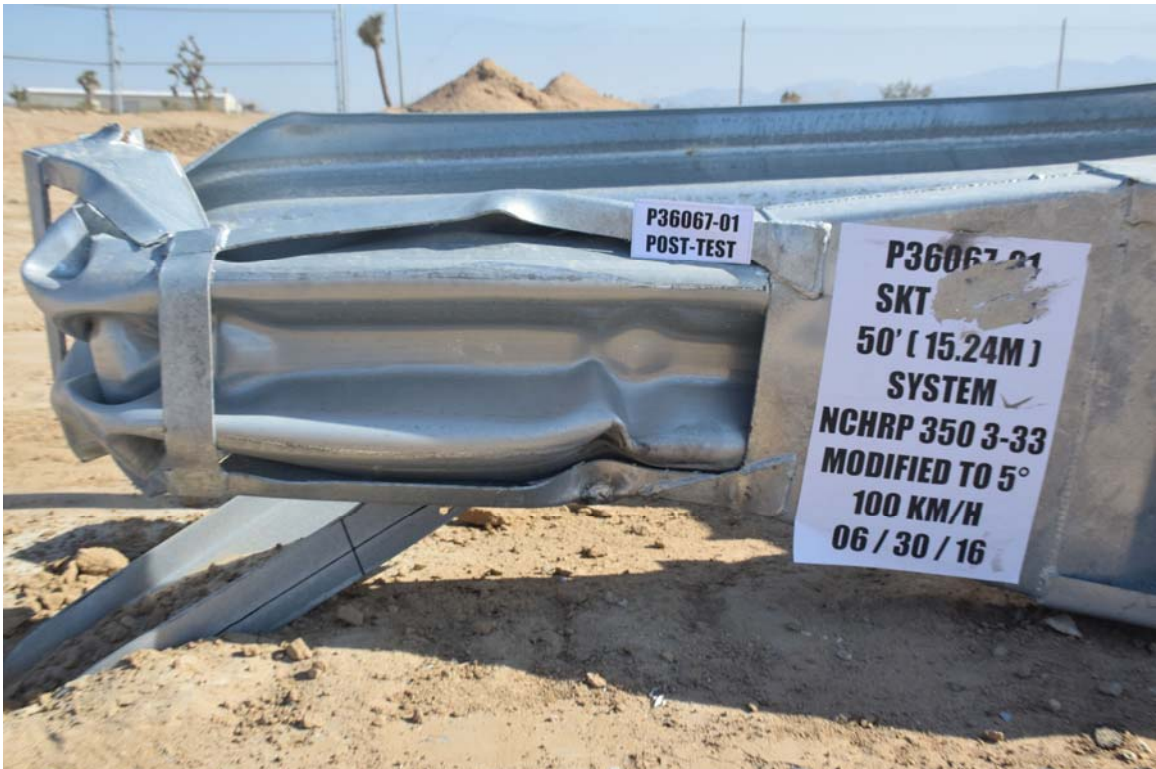
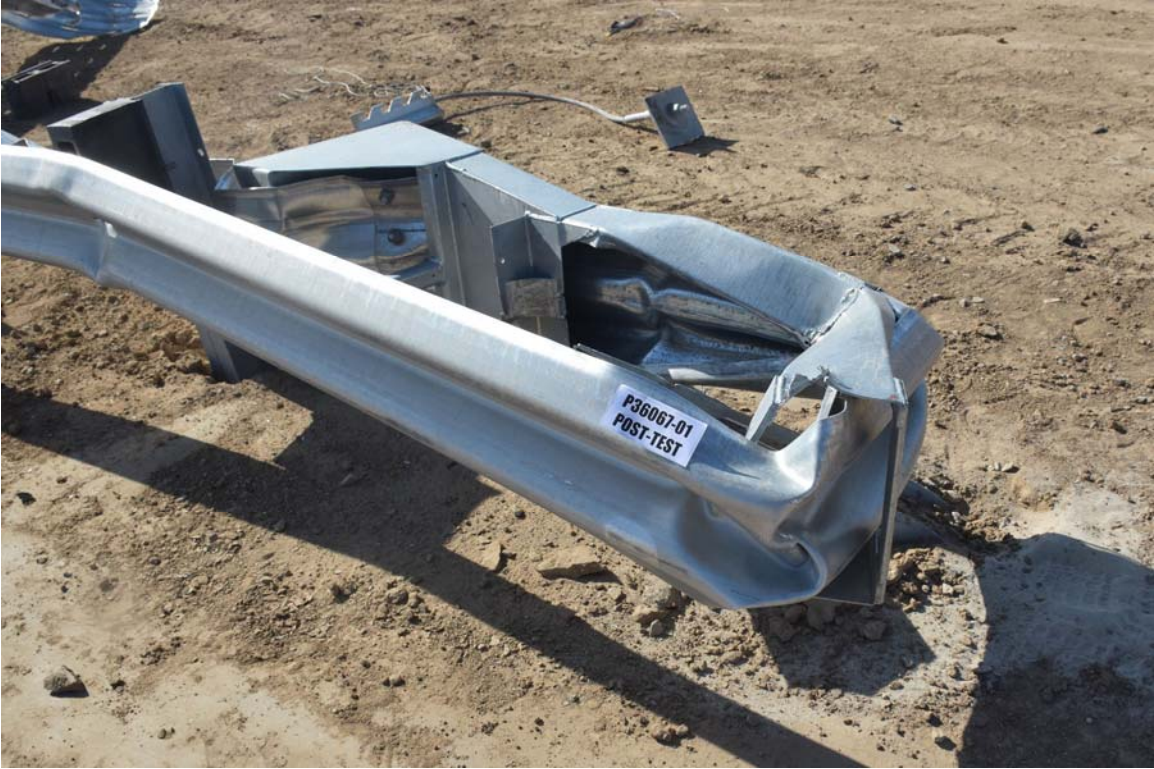
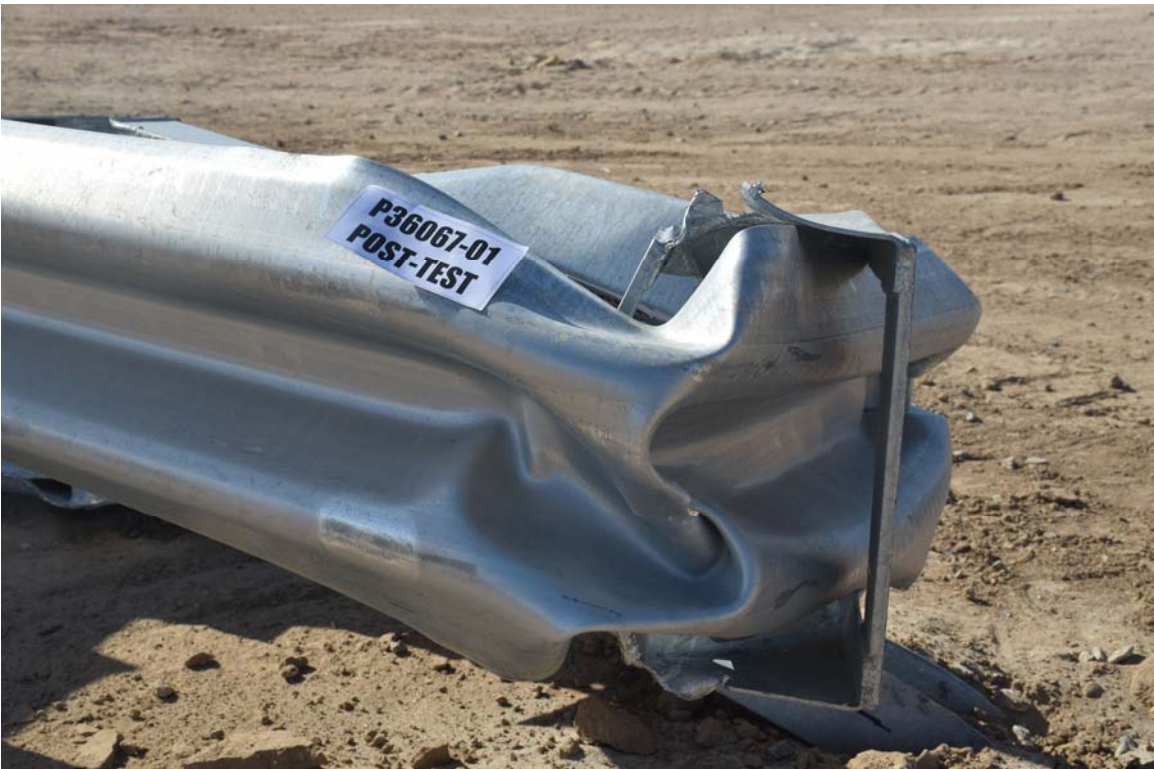
FIGURE 33. Test Article Damage

FIGURE 34. Test Article Damage

FIGURE 35. Test Article Damage

FIGURE 36. Test Article Damage

The test vehicle impacted the SKT SP 350 50' (15.24 m) System at a velocity of 98.46 km/h (61.18 mph). The test vehicle impacted the SKT impact head and pushed it down the guardrail past the first 6 posts. After the SKT extruder head chute passed post 6 the rail buckled and the vehicle continued to the non-traffic side of the article. The test vehicle impacted the extruded section of rail and began tracking back towards the article. The test vehicle impacted the length of need section near post 17 and subsequently rode up the non-traffic side of the article. The vehicle came to rest with its left side wheels on the traffic side of the article 43.3 m (421.1 ft.) downstream from its position at the point of impact. The test article sustained damage from post 1 through post 6. Post 1 top broke away at the connection bolt, post 2 folded to the ground while post 3 through 6 bent towards the ground. The chute on the SKT impact head sustained deformation and a tear on its downstream end. The length of need section was also damaged from post 16 through 23. An overhead illustration of the test vehicle and test article in their pre-test and post-test condition is shown in figure 2 in Appendix D. Sequential photographs of the test sequence are shown on Data Sheet 4.

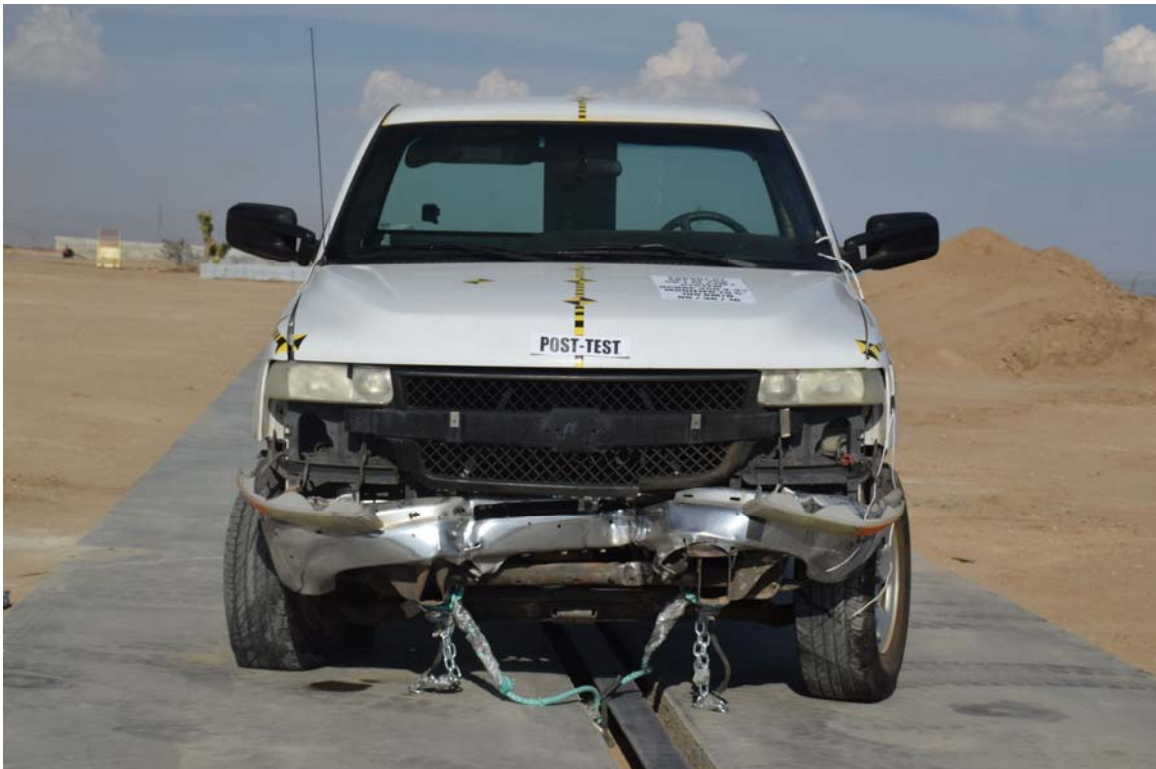
FIGURE 42. Post-Test Front View of Test Vehicle

The vehicle sustained damage to the front end including the front bumper and grill as a result of the impact with the SKT SP 350 50' (15.24 m) System. The front right tire was also punctured. The occupant compartment was not penetrated as a result of the impact.

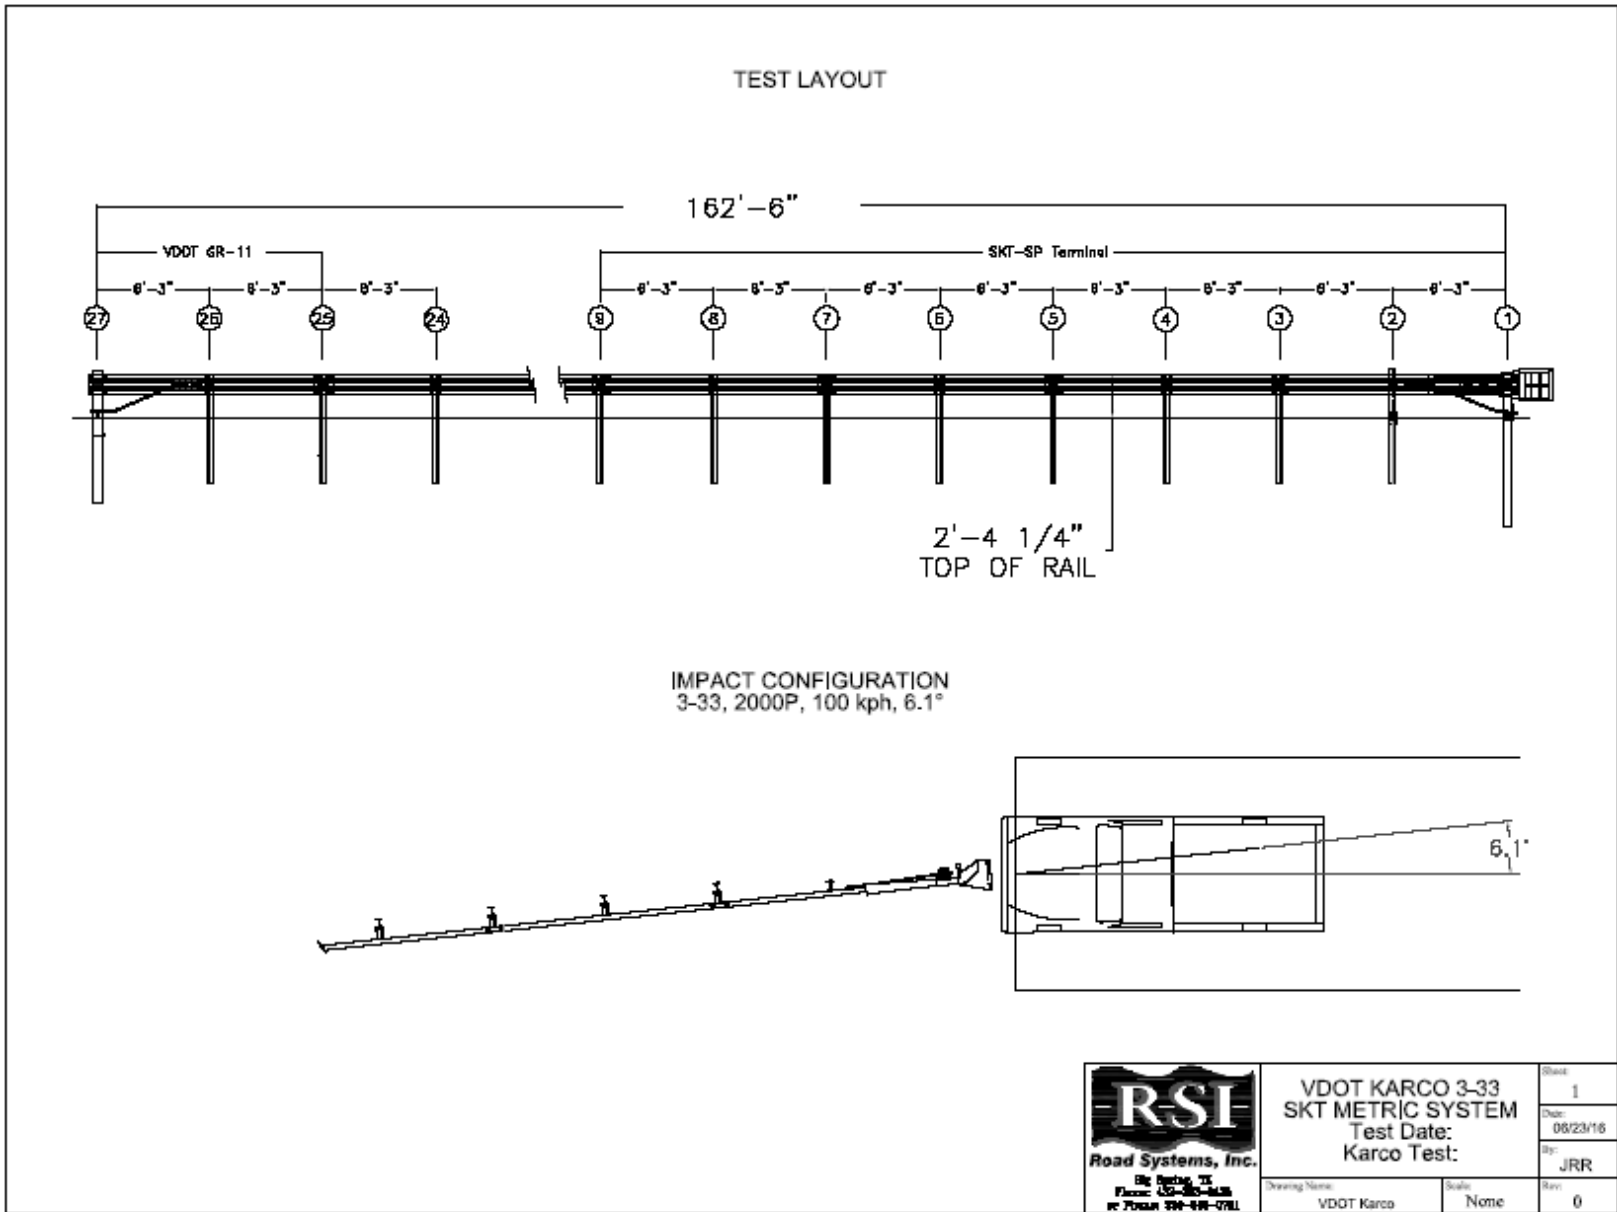
FIGURE 1. Manufacturer's Drawing

Photographs of the as-tested unit and installation are available in Appendix A of this report. Manufacturer's drawings are available in Appendix D. The installation instructions are included on KARCO CD-R 2016-4054

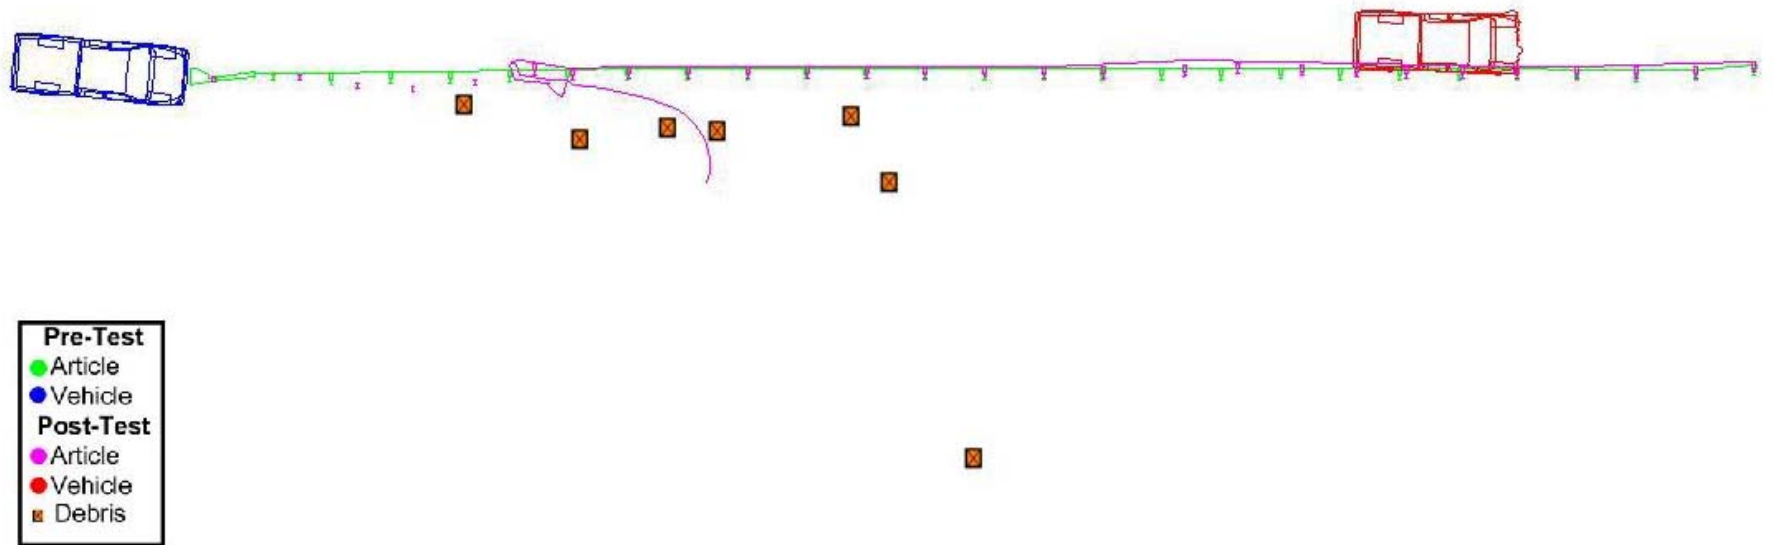
FIGURE 2. Overhead Illustration
FINAL PAGE OF REPORT
