TEST REPORT FOR:

**Virginia Department of Transportation
X Tension Tangent 37.5' (11.43 m) System**

TR-P36133-01-NC

Test Article: X Tension Tangent 37.5' (11.43 m) System Project No. P36133-01
 Test Program: 100 km/h 5° Guardrail Terminal Impact Test Test Date: 08/18/16

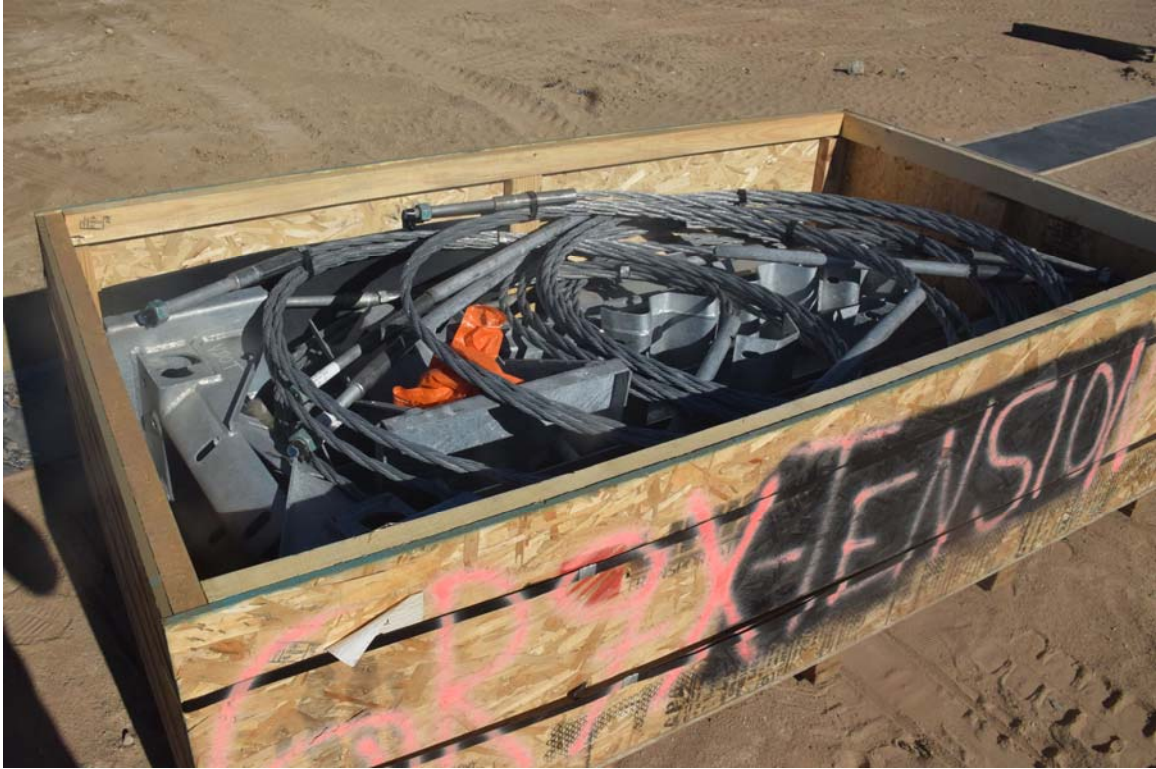
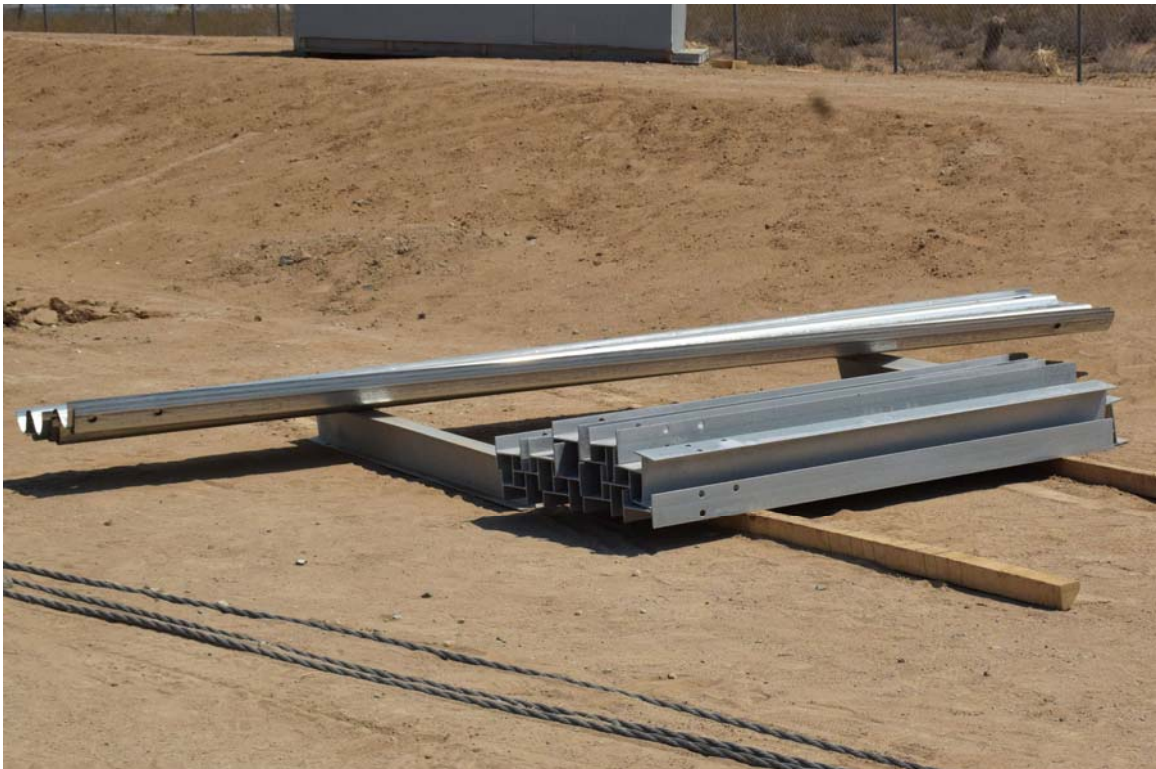
FIGURE 1. Test Article, As Received

FIGURE 2. Test Article, As Received

The Lindsay Corporation X Tension Tangent 37.5' (11.43 m) System is a standard post guardrail terminal/end treatment. The as-tested X Tension Tangent 37.5' (11.43 m) System consisted of an impact head, hinged post, crimped post, slider panel, slider bracket cable bracket, ground strut, soil anchor, two cables, four (4) standard line post and three (3) W-beam panels. The terminal was installed with a 50:1 flare and a rail height ranging from 705 mm (27.75 in.) to 730 mm (28.75 in.) per Virginia Department of Transportation (VDOT) Road and Bridge Standards.

Photographs of the as-tested unit and installation are available in Appendix A of this report. Manufacturer's drawings are available in Appendix D. The installation instructions are included on KARCO CD-R 2016-4058.

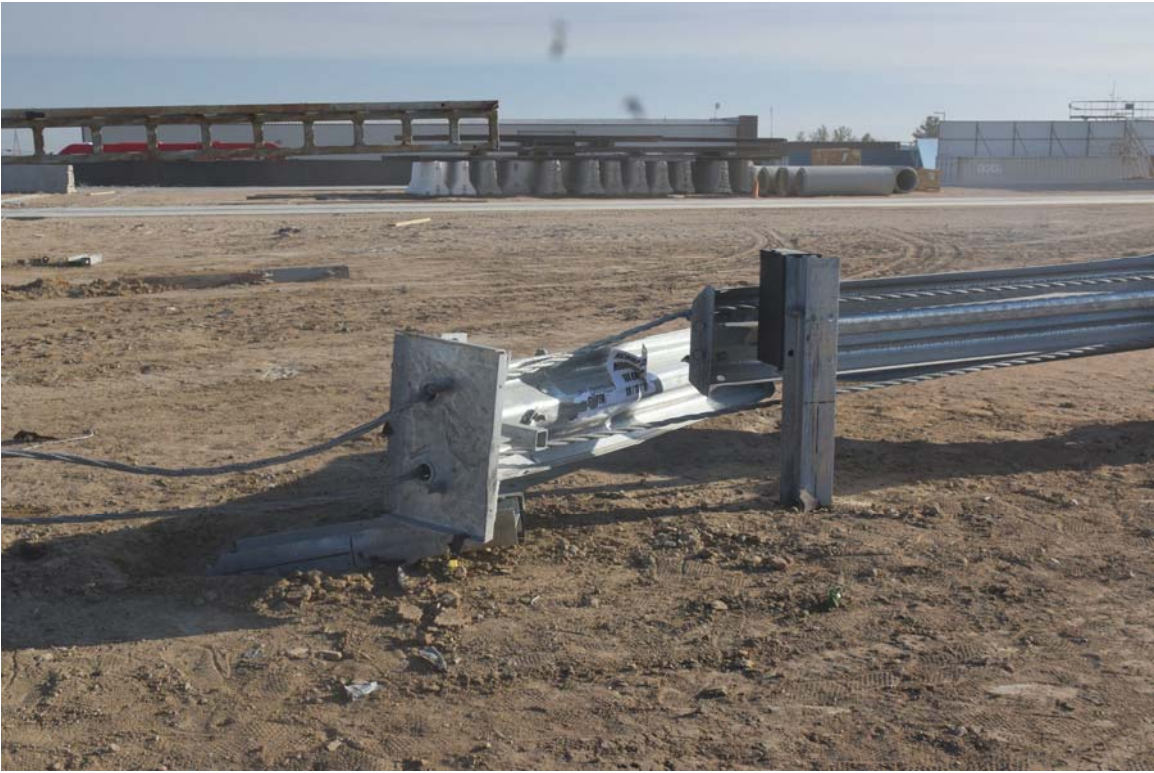
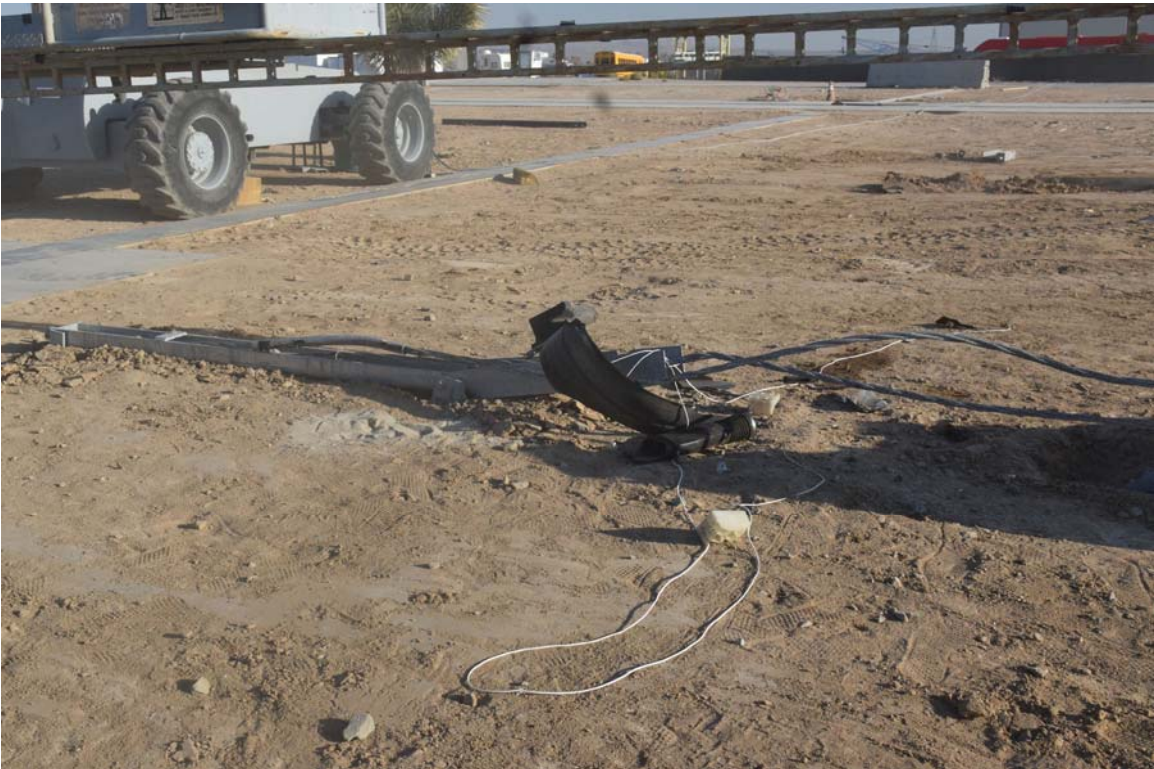
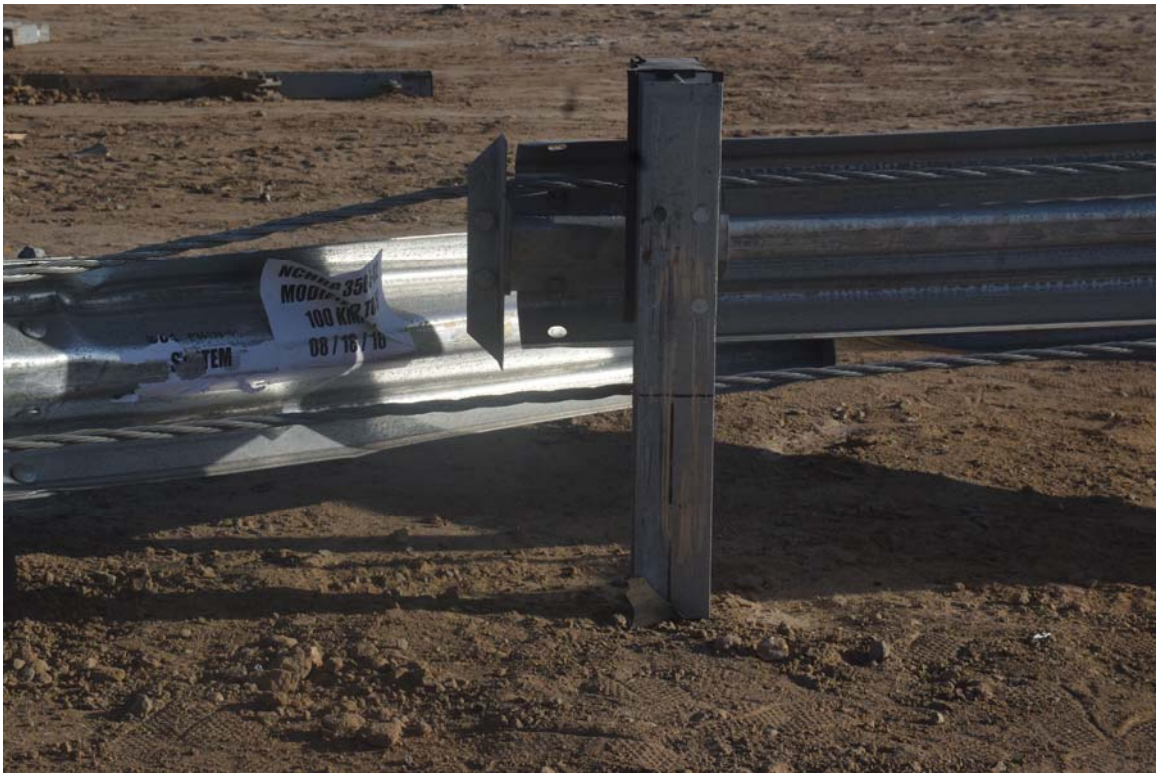
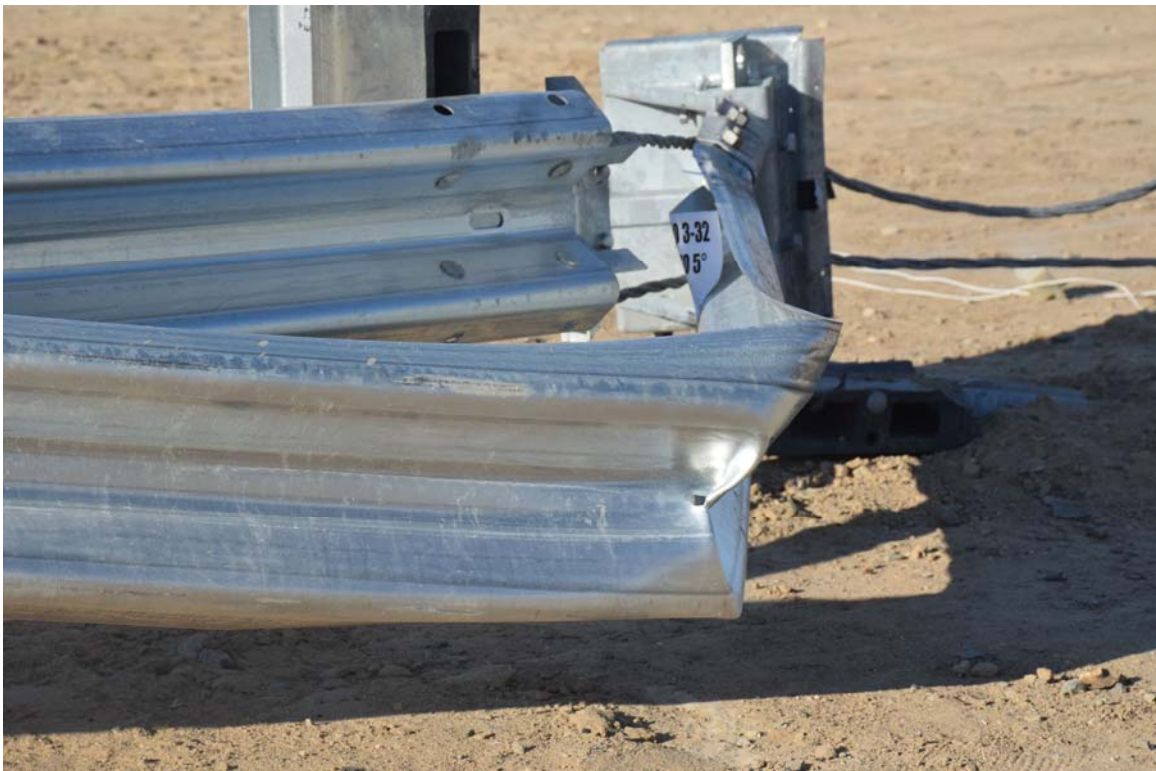
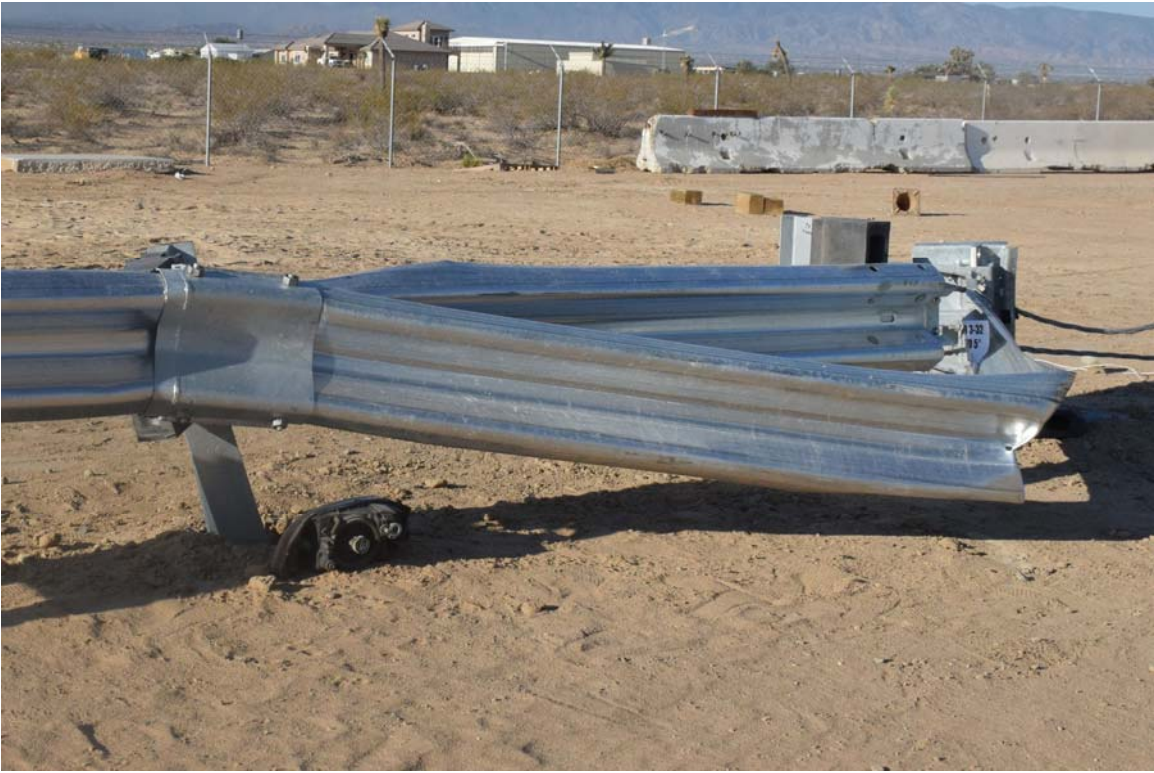
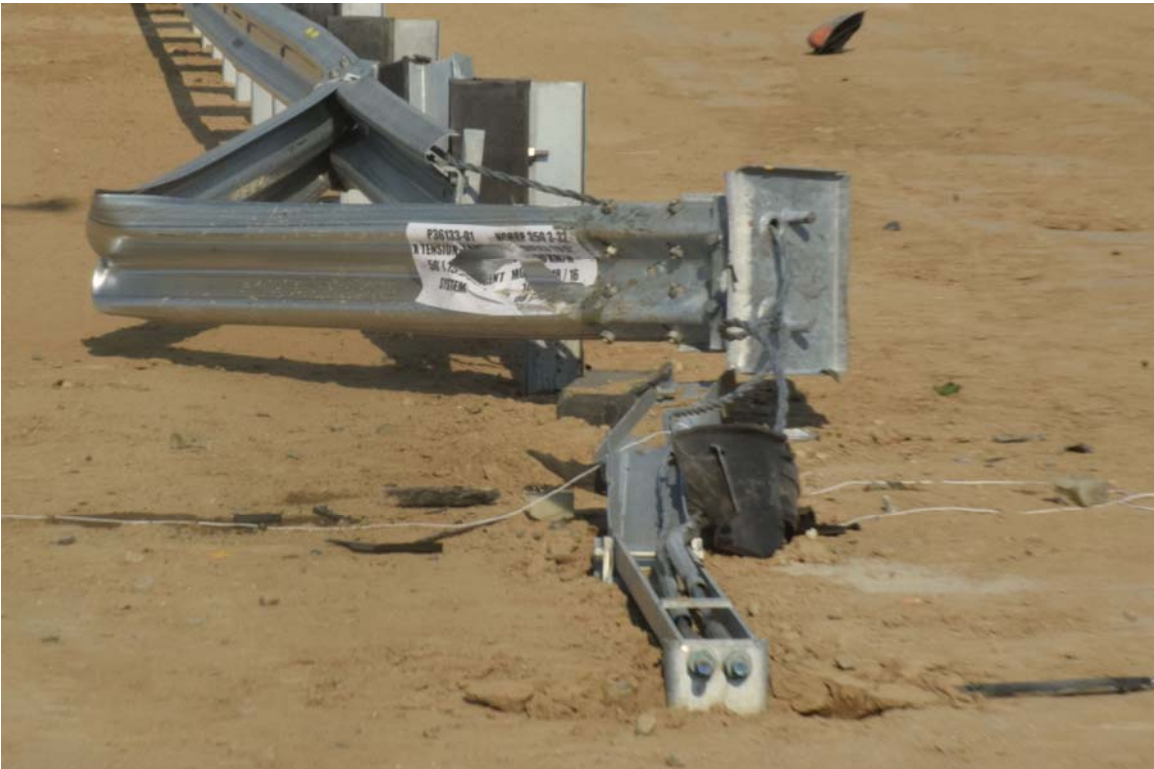
FIGURE 33. Test Article Damage

FIGURE 34. Test Article Damage

FIGURE 35. Test Article Damage

FIGURE 36. Test Article Damage

FIGURE 37. Test Article Damage

FIGURE 38. Test Article Damage

The test vehicle impacted the X Tension Tangent 37.5' (11.43 m) System at a velocity of 100.52 km/h (64.46 mph). The test vehicle impacted the impact head and pushed the first W-beam rail down rail 2. Rail 1 kinked approximately mid-span as it slid down rail 2. The test vehicle's rear end subsequently pitched up and the vehicle rotated clockwise toward the traffic side of the article. The test vehicle came to rest 3.7 m (12.1 ft) downstream from the initial point of impact. As a result of the impact the anchor and post 1 through post 4 shifted downstream in the soil. The top of post 1 tore at the hinge; post two bent rearward and tore at the crimp. Post 4 tore from the W-beam panel and bent rearward. The impact head and slider panel sustained deformation. An overhead illustration of the test vehicle and test article in their pre-test and post-test conditions is shown in Figure 2 in Appendix D. Sequential photographs of the test sequence are shown on Data Sheet 4.

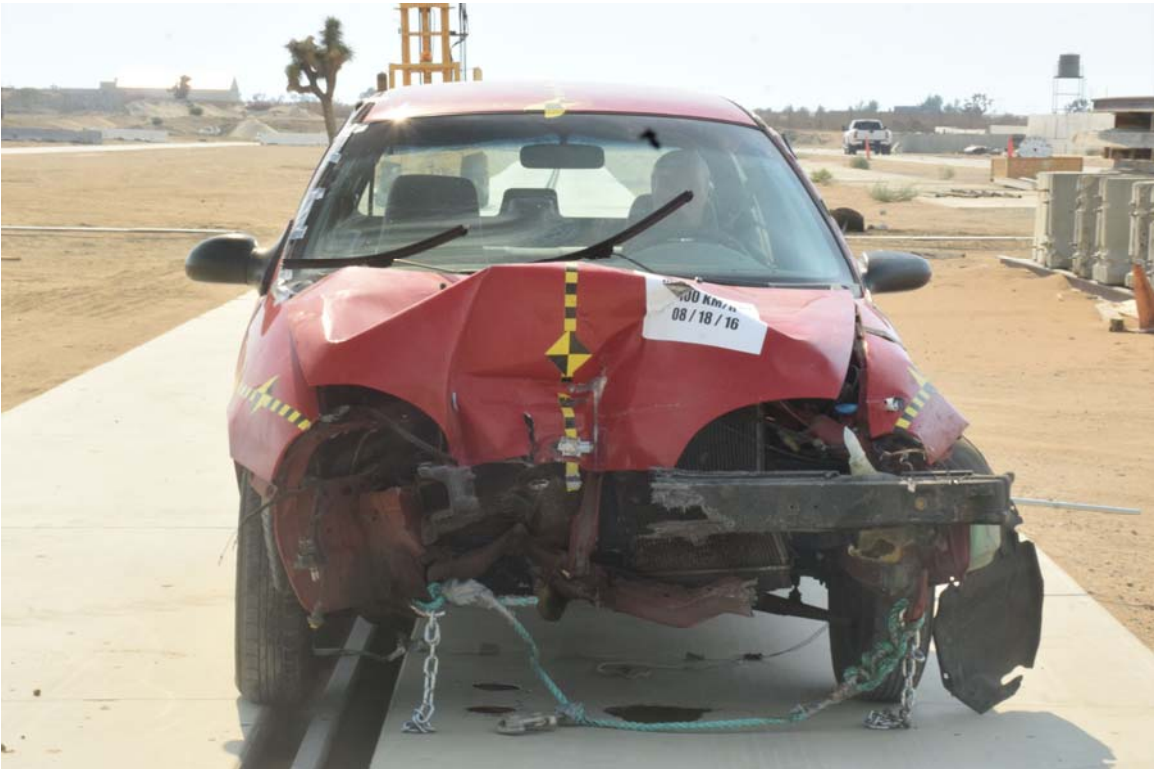
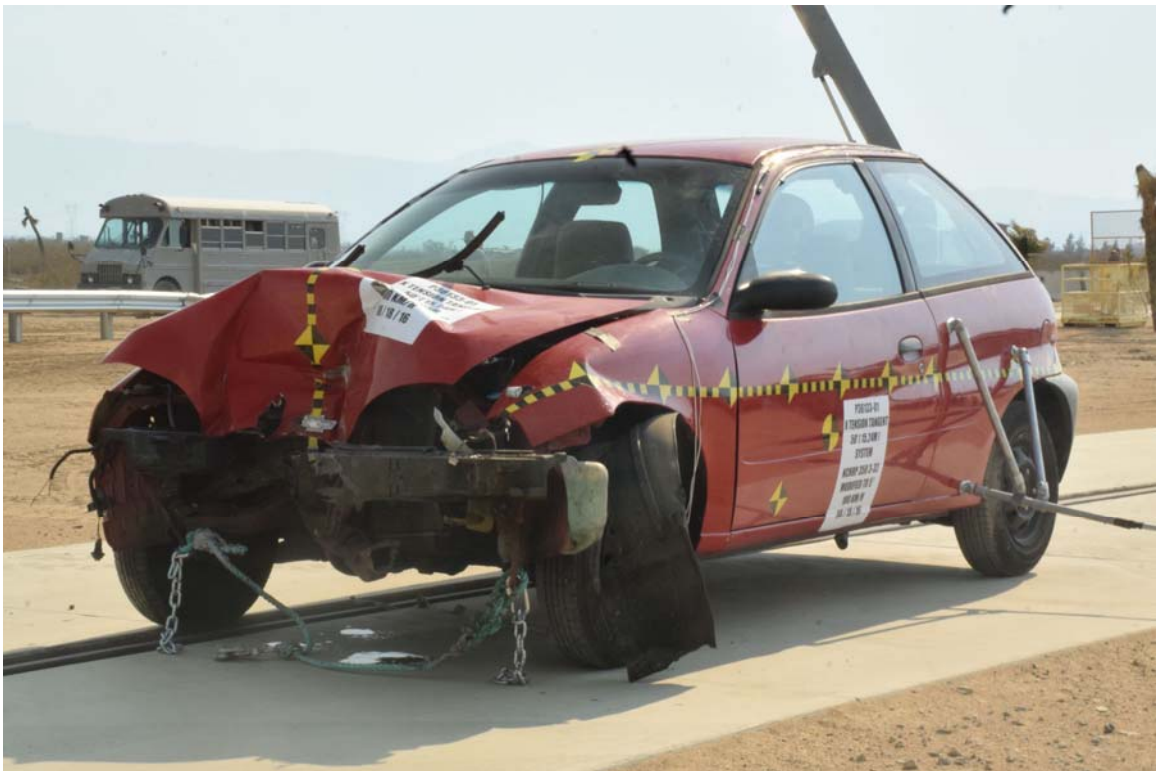
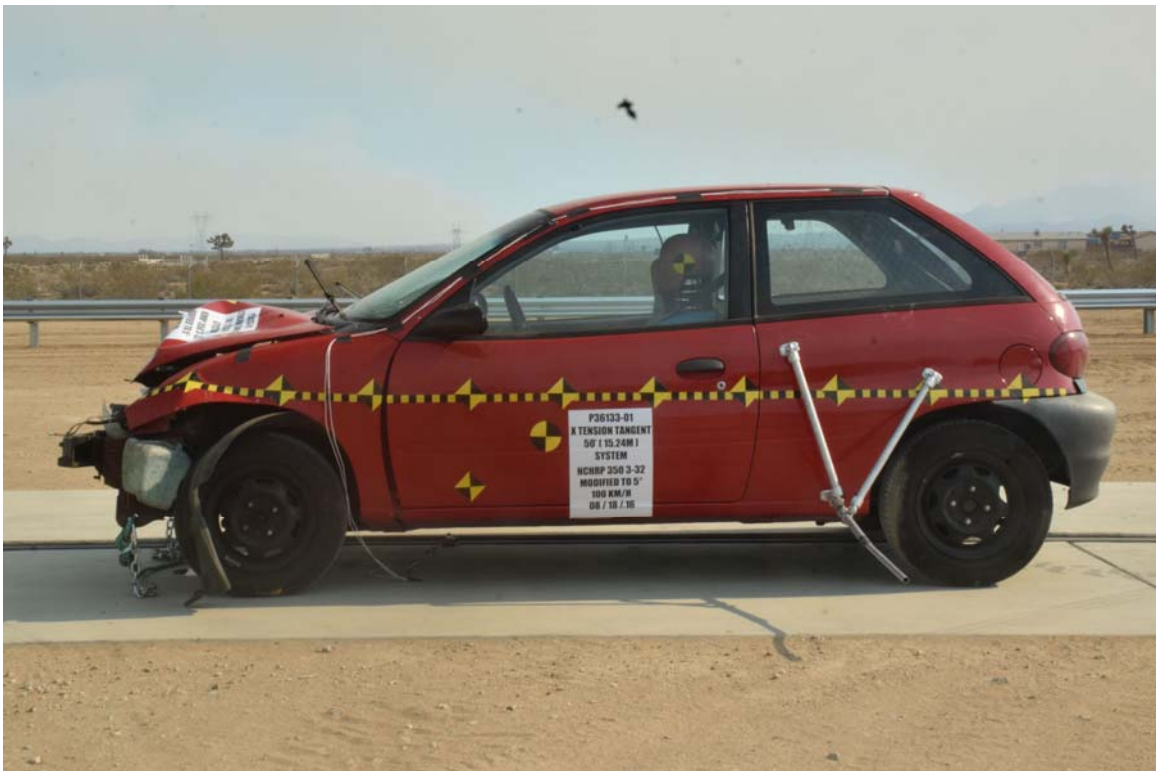
FIGURE 40. Post-Test Left View of Test Vehicle

FIGURE 42. Post-Test Left Front $\frac{3}{4}$ View of Test Vehicle

FIGURE 44. Post-Test Front View of Test Vehicle

The vehicle sustained damaged to its front end as a result of the impact with the X Tension Tangent 37.5' (11.43 m) System. The test vehicle's hood and front left quarter panel sustained deformation. The front bumper beam broke at its center and the radiator was crushed. The occupant compartment was not penetrated as a result of the impact.
