Lylburn Downing Middle School

Walkabout Report

Lexington, Virginia

May 2017

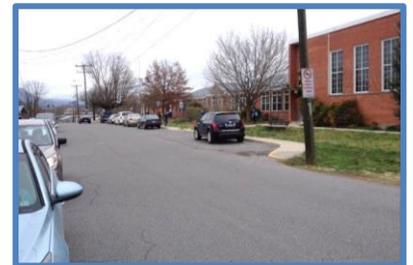
Figure 2 – Parents Queuing along Diamond St near the side entrance of LDMS

During the 40 minute debrief, each team shared their observations. It was discovered that drivers are not using the loop entrance and parking lots to their full capacity. Many parents park across from the school along Diamond Street or a few blocks away on North Lewis Street (**See Figures 2 and 9**) to wait for their children. As the use of the parking lot and loop decreases, the walkability of the surrounding area also decreases because of the dispersal of vehicle traffic and its associated impacts.

B) Reconstruct sidewalk ramps and add a crosswalk to the intersection of Maury Street and Diamond Street.
C) Parking Lot and Loop Improvements. Parent newsletter encouraging them to use the parking lot as a safety precaution.
Zone 3

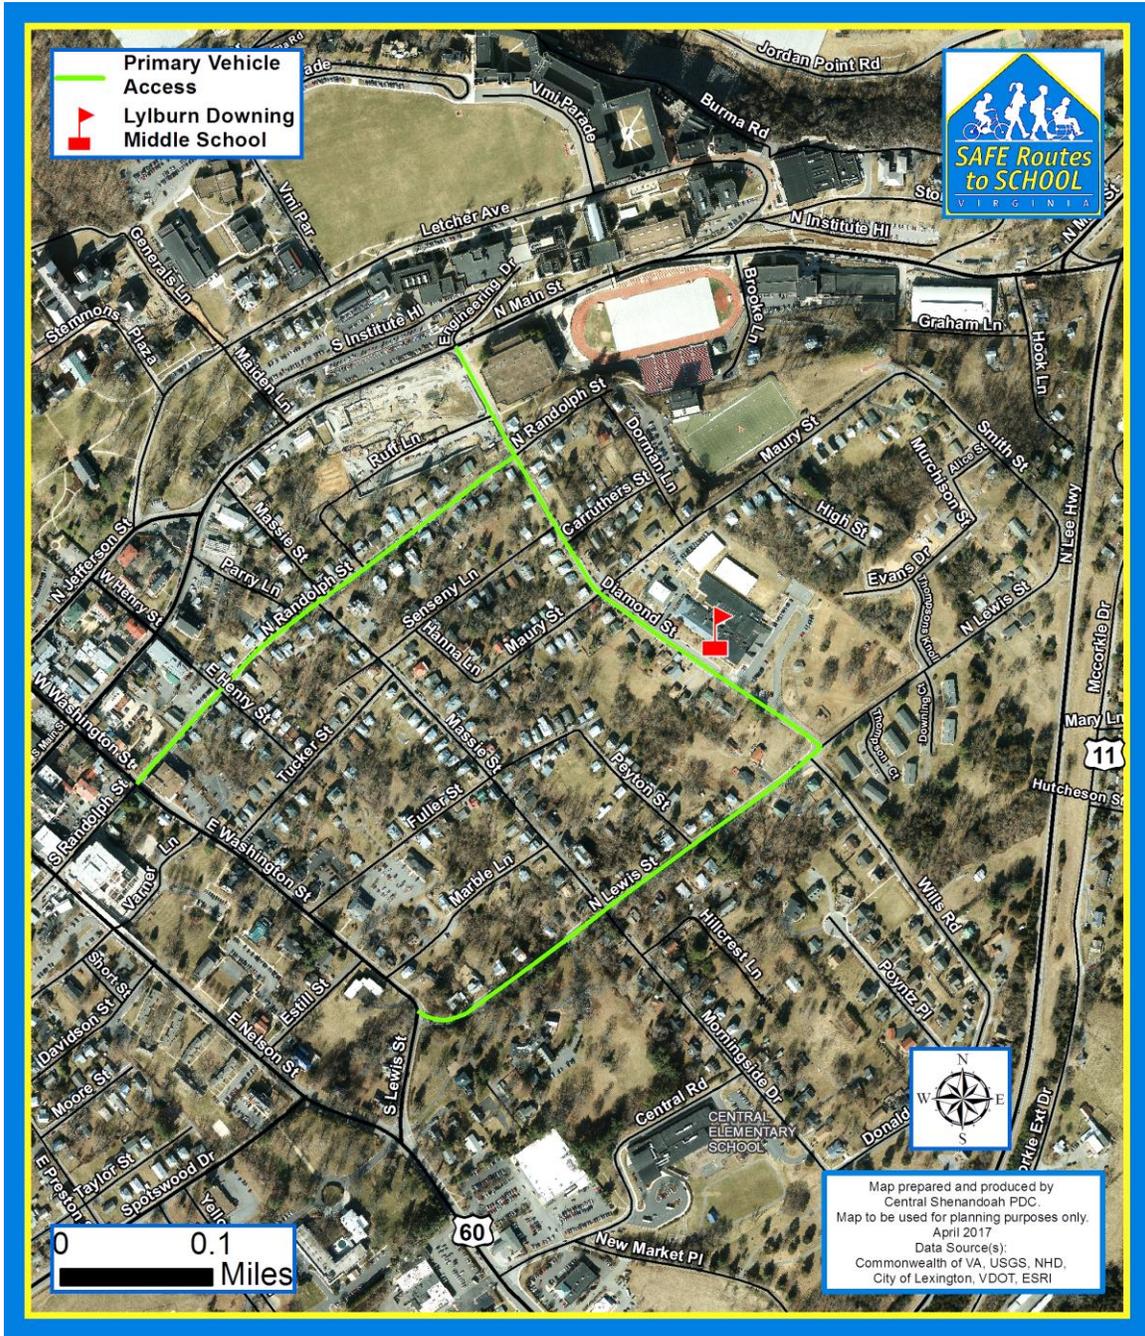
Table 1 - Road Information Table

Street Name	2015 Average Annual Weekday Traffic (AAWDT)	No. of Travel Lanes in each direction	Speed Limit	Road Width	Road Classification
Diamond	1500	2	25	22	Local, residential, on-street parking one side
N Lewis St	1600	2	25	33	Local, residential, on-street parking one side
N Randolph St	Unknown	2	25	26	Local, residential, on-street parking both sides

The width of Diamond Street as shown in **Table 1**, between N. Randolph Street and Maury Street presents challenges to widening the sidewalks. There is no barrier between pedestrians and oncoming traffic on this portion of Diamond Street because street parking is on the opposite side of the street (**See Figure 5**). The hilly terrain also presents unique challenges to this stretch of road. During ice and snow events, if the sidewalks are not cleared, students have to walk in the street with vehicle traffic. A safety fence was installed by the City to separate the rapid grade change between the front yards of homes and the sidewalk.

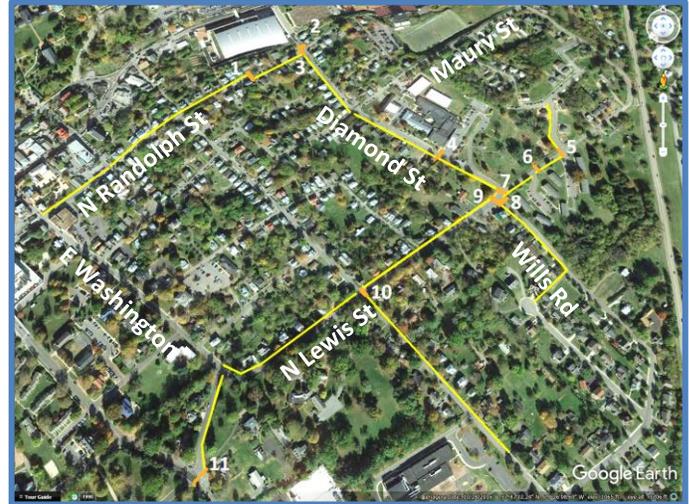
Map 2 – Primary Sidewalks (Yellow) and Crosswalks (Orange)

The City of Lexington currently does not maintain an inventory of their sidewalk network. Therefore, a preliminary sidewalk and crosswalk map was developed only to highlight the primary network relevant to LDMS student travel. Upon first glance, the sidewalk and crosswalk network outlined in **Map 2** of the neighborhood surrounding LDMS is fairly robust and complete. Yet, the quality and condition of the sidewalks is not ideal.

The sidewalks in the Diamond Hill neighborhood are four feet wide. The lack of ADA ramps and obstructions make wheelchair travel very difficult throughout the network. Some of the crosswalks throughout the network have faded and washed out paint. There are two crosswalks in the primary network that are missing at the intersections of Maury Street and Diamond Street and E. Washington and N. Lewis Street. These intersections have geometry that is can be challenging for all users. **See Figure 3.**

D) Create a North Lewis Street bike boulevard with signage, road markings and a protected bike lane on one side of the street if possible
Other
A) Recommend a city-wide pedestrian and bicycle infrastructure assessment and inventory be performed. A GIS shapefile with relevant attribute data will be developed.

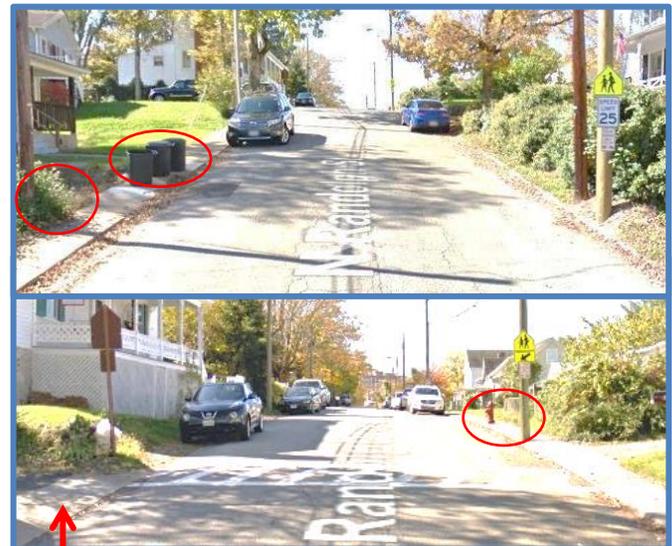
Figure 4 – N Randolph St traveling south

There are a significant number of obstructions on the sidewalks along N. Randolph Street and at the Diamond Street / Maury Street intersection. As shown in **Figure 4**, sidewalk obstructions include fire hydrants, residential trashcans, driveways, flora, and utility poles. The on-street parking on both sides of the street limits space for bicycle traffic.

Residential driveway

Zone 1
A) Create a North Randolph Street bike boulevard with signage, road markings and removal of on-street parking on one side of the street if possible.

B) North Randolph Street: Widen the sidewalk in order to move utility poles and fire hydrants out of the through-way.
C) Re-stripe the existing crosswalks at the intersection of North Randolph and Diamond Streets.

D) Re-locate N. Randolph Street crosswalk away from the adjacent residential driveway to a more suitable location.
Zone 2
A) Re-locate main entrance crosswalk away from the adjacent residential driveway to a more suitable location.

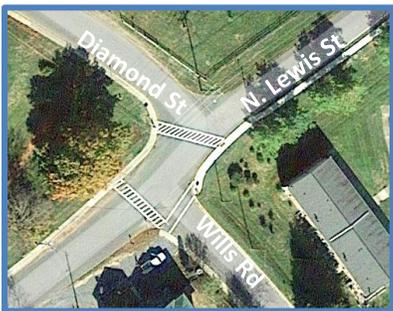
Figure 6 – Diamond / N. Lewis / Wills Offset Intersection

N. Lewis Street’s sidewalk infrastructure is in good condition and does not have the same kinds of obstructions as seen along N. Randolph Street. The City Police have indicated that speeding vehicles are an issue on this street and that the visibility of speed signage should be improved. The offset Diamond Street and N. Lewis Street intersection seen in **Figure 6** also poses operational and visibility issues for all users.

A) Diamond Street/North Lewis Street Intersection Improvements <ul style="list-style-type: none"> a. Long Term: Realign Diamond Street with Wills Road b. Short Term: Remove the crosswalk at the southern leg of the intersection (connecting to the eastern side of Lewis Street at the Montessori School), and formalize the diagonal crosswalk from the southwestern corner of the intersection to the eastern side of Lewis Street adjacent to the apartment complex.

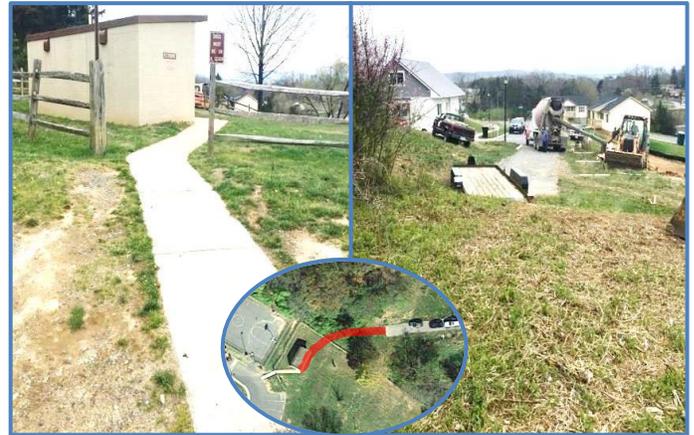
Figure 7 – Thompson’s Knoll Connection

Figure 7 shows a potential bicycle and pedestrian access point highlighted in red behind the school parking lot. The lack of pedestrian infrastructure at this location creates a barrier to non-motorized travel not only for the Thompson’s Knoll neighborhood, but also for about thirty homes behind the school, and the Downing Court apartments. Though parts of Thompson’s Knoll are still under construction, a logical connection to the LDMS may help to serve future residents.

B) Thompson’s Knoll Trail Connector

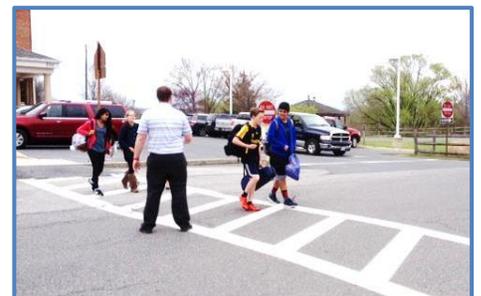
Figure 8 – Main Crosswalk during Dismissal

Parent vehicles began queuing at 2:50 P.M. in the parking lot, in front of the school along Diamond Street, and North Lewis Street. All vehicle traffic related to school dismissal had cleared by 3:15 P.M. There was only one crossing guard, a teacher, at the main entrance of the school to cross Diamond Street. The operation of the crosswalk near the main school entrance ran smoothly. The crossing guard was attentive and effective at getting students across safely and vehicles were properly yielding and driving safely.

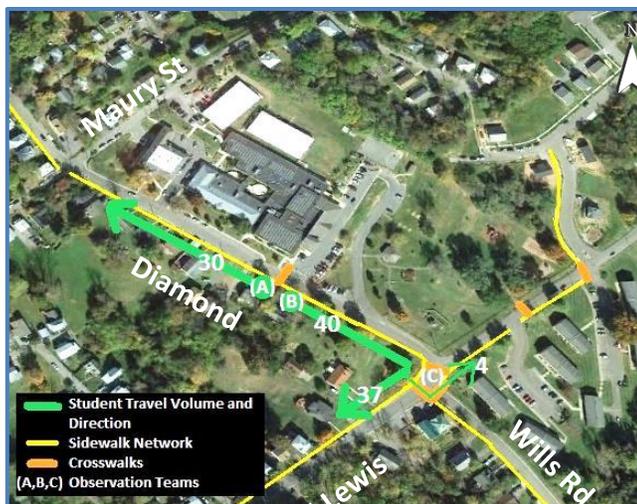
Map 3 - Number of Students, Travel Flow and Observation Team Locations during Dismissal

Observation teams were stationed at strategic locations based on advice from school administration, local staff, police, and parents. The roles of each observer were discussed and nine people were divided into three teams A, B and C. **Map 3** shows the location of the teams and observed pedestrian counts.

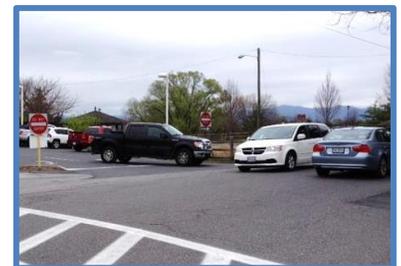
Figure 10 – LDMS Parking Lot Exit

Motor vehicle observers witnessed a greater amount of vehicle traffic coming to and from the direction of North Randolph Street and North Main Street. There was one instance where an observer witnessed a driver texting on Diamond Street in front of the school near the main crosswalk. Parent traffic and vehicle pickup along Diamond Street in front of the school was heavy. In two cases, parents swung open car doors into the road causing vehicles to go into the opposite lane to get around. Sergeant Huffman pointed out that vehicle flow in and out of the parking lot as shown in **Figure 10**, was smooth and witnessed no unsafe driving habits at this location.

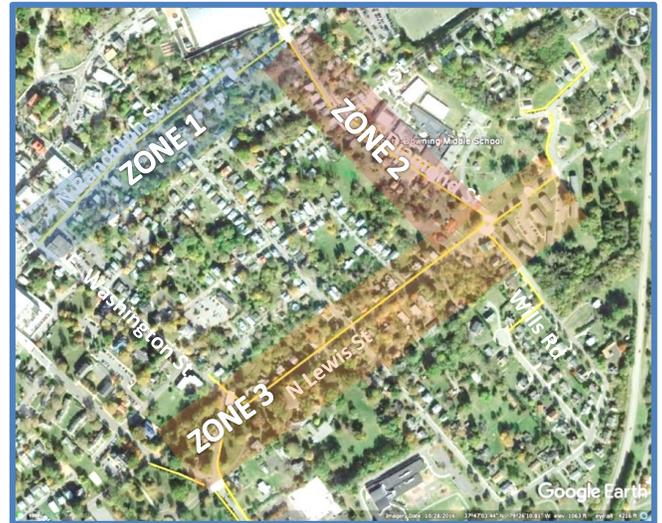
Map 5 – Zones of Improvement

During the debrief session, a list of ideas and recommendations were brainstormed on how to potentially resolve certain issues. The zones created for **Map 5** are based on areas that share similar geography, character and infrastructure. The recommendations were then organized by zone for ease of reference in **Table 2**.

B) North Lewis Street Speed Signage—install additional signage closer to the Diamond Street intersection. Consider increasing enforcement activity for a time as well.

C) North Lewis Street/East Washington Street Intersection Improvements—restripe, improve the pedestrian refuge in the center, and expand the curb ramp/landing pad at each side of North Lewis Street.
