Triangle Elementary School Walkabout Report

On May 30, 2018, stakeholders at Triangle Elementary School in Triangle, Virginia met to examine the walking and bicycling networks around the school and identify potential improvements to be included in a future Transportation Alternatives Program grant application. Their participation in a VDOT Safe Routes to School (SRTS) Walkabout shows their support for improving the walking and bicycling environment and increasing the number of students safely walking and bicycling to school.

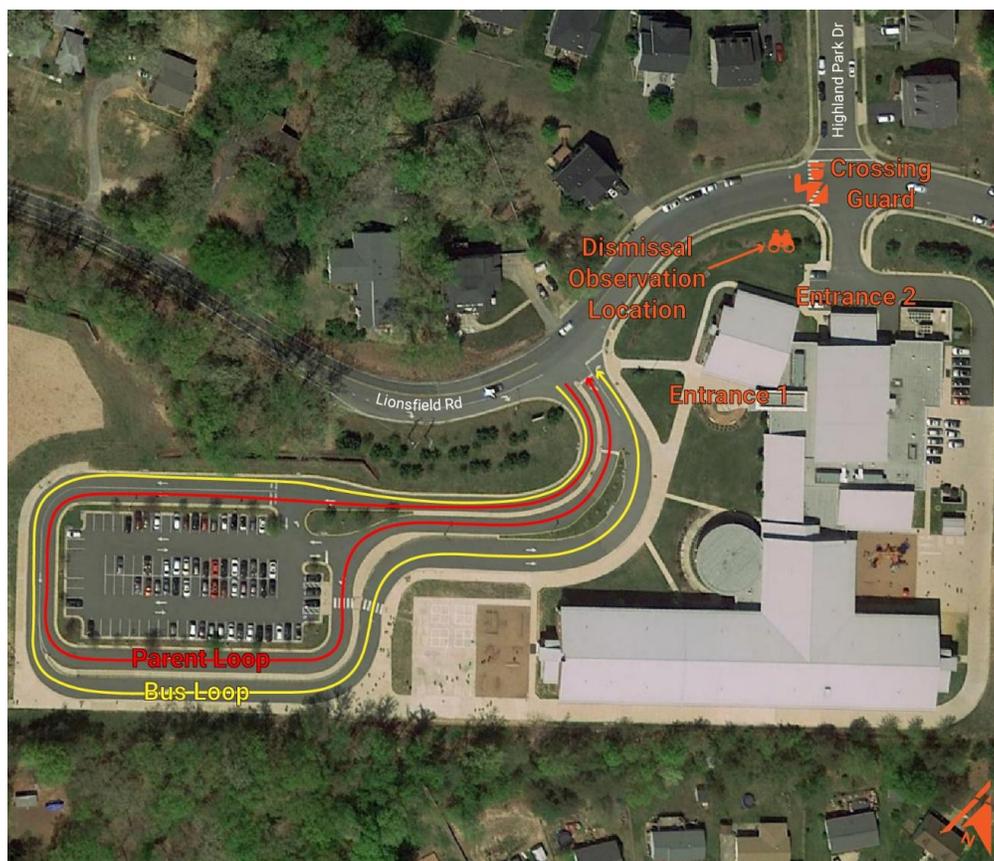
Figure 3: Triangle Elementary Site, Observation Location, and Key Elements of Arrival and Dismissal Circulation

Figure 3 shows the walkabout observation location and key elements related to arrival and dismissal circulation.

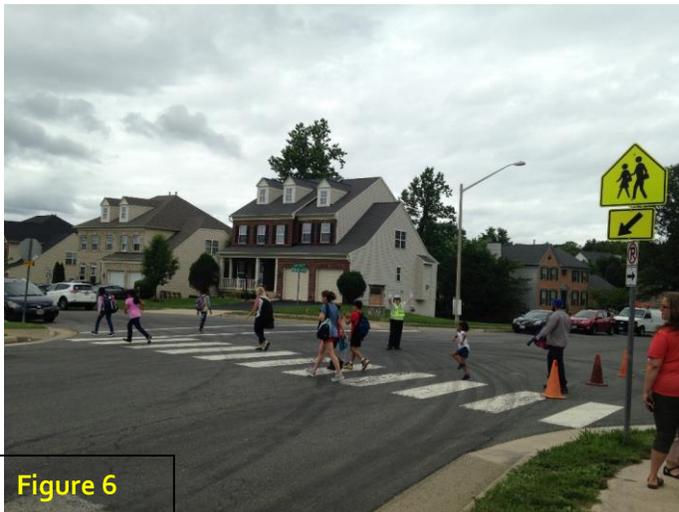
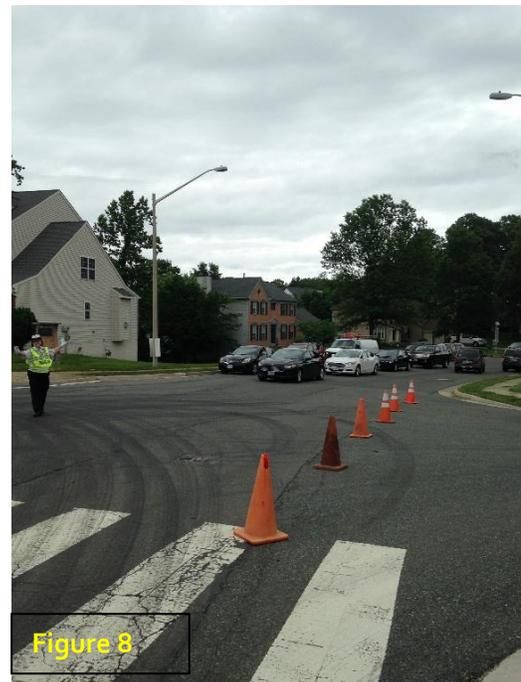
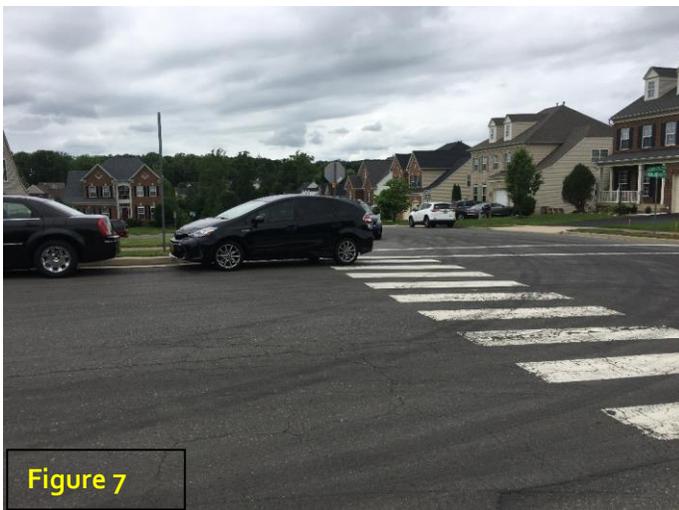
- 30-40 students were released from Entrance 2, almost all of whom crossed Lions Field Road with the crossing guard at Highland Park Drive (Figure 6).
- Some students went to parked or standing cars, while others continued into the neighborhood west of the school.
- A standing car temporarily blocked the west side of the Lions Field Road crosswalk (Figure 7).
- Several other cars parked illegally on the west side of Lions Field Road south of Highland Park Drive.
- The crossing guard reported that illegally parked cars frequently blocked her view of northbound traffic on Lions Field Road. She also mentioned motor vehicle speeds and yielding behavior as safety concerns on Lions Field Road.
- The crossing guard places cones across the school's service entrance and parking area next to Entrance 2 to prevent parents from attempting to drop-off or pick-up there (Figure 8).

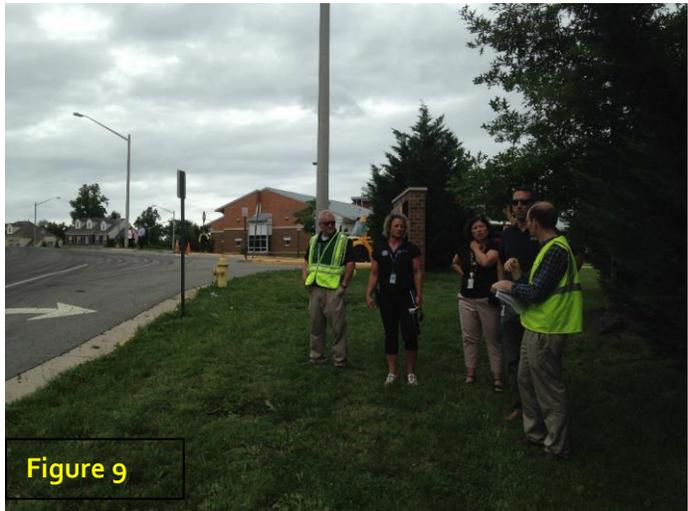
Following the dismissal observation, the Walkabout Team walked south on Lions Field Road to the end of the school property to get a sense of walking conditions on Lions Field Road between the school and Fuller Heights Road (Figure 9).

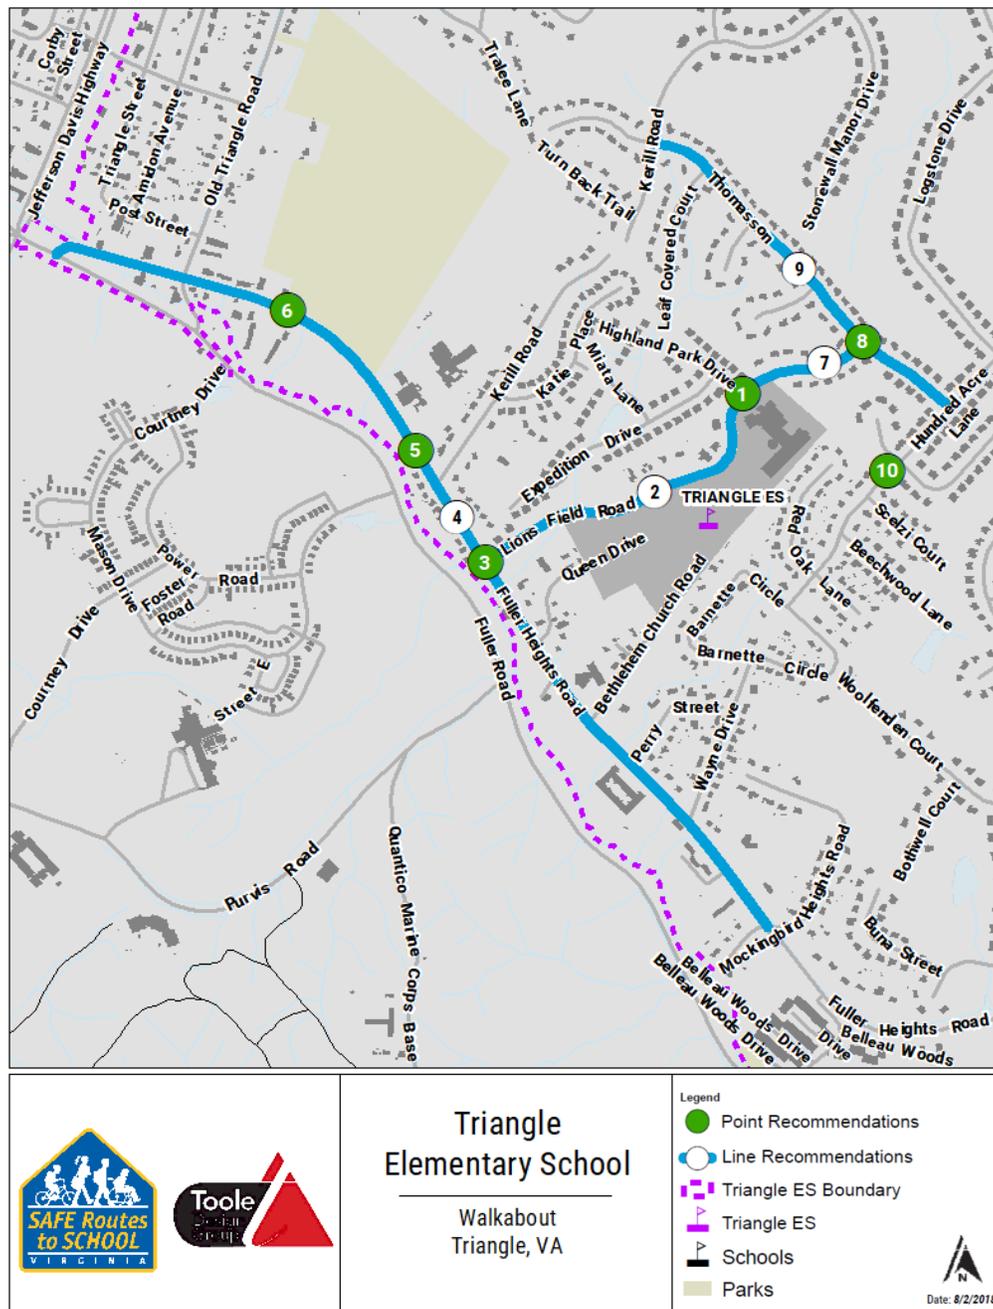
Figure 4: Infrastructure Recommendations Map

A map of the infrastructure recommendations for Triangle Elementary School is provided in Figure 4 below. This map is followed by tables detailing the issues and recommendations at each location. A glossary of engineering terms is provided in Appendix C and key policies supporting the recommendations are highlighted in Appendix D.

Lions Field Road at Highland Park Drive			
Map ID	Issue	Recommendation	Timeframe ¹
1	<p>Difficult crossing. Almost all students who currently walk to Triangle Elementary cross at this intersection, where a crossing guard is posted to assist them crossing the street. The crossing is relatively long (over 50 feet) and both the crossing guard and members of the Walkabout Team reported concerns about speeding and a lack of driver yielding. The crossing guard reported that illegally parked cars obstruct her view of oncoming traffic, and several cars were observed parking illegally on the northwest (non-school) side of Lions Field Road south of this intersection, with one standing car observed blocking the crosswalk. Members of the Walkabout Team reported that drivers also park cars illegally on the southeast (school) side of Lions Field Road during arrival, although illegal parking is more of an issue on the northwest (non-school) side. Signed NO PARKING zones have been established on both sides of the intersection south of this intersection.</p> <p>Figures 6,7,8,10, and 11 show existing conditions at this intersection.</p>	<p>In the short-term, add painted curb extensions with flex post delineators to prevent illegal parking on Lions Field Road and shorten the pedestrian crossing distance. Also, add an in-street pedestrian crossing sign (R1-6) to the crosswalk across Lions Field Road to encourage yielding. In the long-term, install permanent curb extensions and/or a raised crosswalk.</p>	Short, Long

Lions Field Road between Fuller Heights Road and Triangle Elementary			
Map ID	Issue	Recommendation	Timeframe ²
2	<p>Missing Sidewalk. This segment of Lions Field Road is a critical link for pedestrian and bicycle access to Triangle Elementary. It is the only possible route that many students living near the school can take due to the disconnected nature of the street network. It has no sidewalk or shoulder, several blind curves, and steep drop-offs for drainage ditches in some locations. During observations, drivers appeared to exceed the 25 mph speed limit. A family with three young children was observed walking along the road to the playground at Triangle Elementary after school hours.</p> <p>Figures 12 and 13 show existing conditions along this segment.</p>	<p>Add a sidewalk or side path to the southeast side of Lions Field Road and consider reducing road speed to 20 mph in the school zone. The southeast side is preferred for several reasons:</p> <ul style="list-style-type: none"> • The school is on the southeast side • The drainage ditches are not as steep as on the northwest side. • There is limited space for a sidewalk due to homes placed fairly close to the roadway on the northwest side. <p>If the recommended sidewalk or path is installed, mark a high-visibility crosswalk across the drop-off/pick-up driveways where they intersect Lions Field Road to connect the sidewalk/path to the front of the school. Curb extensions and/or a median crossing island should be considered at the driveways to minimize pedestrian and bicycle crossing distances and encourage driver yielding.</p>	Medium

Fuller Heights Road at Lions Field Road			
Map ID	Issue	Recommendation	Timeframe ³
3	<p>Difficult Crossing – This is the closest crossing of Fuller Heights Road to Triangle Elementary. If the path along Lions Field Road is constructed, demand for crossing at this location is likely to increase. The speed limit on Fuller Heights Road is currently 35 mph. There is a marked crosswalk on the east side of Fuller Heights Road across Lions Field Road. However, there are currently no marked crosswalks across Fuller Heights Road at this location.</p> <p>Figures 14 shows conditions at this intersection.</p>	Strip a high-visibility marked crosswalk across the southern leg of the Fuller Heights Crossing. Add rectangular rapid flashing beacon, appropriate pedestrian crossing signage, and ADA compliant curb ramps to support this crossing.	Medium

Fuller Heights Road between Fuller Road and Mockingbird Heights Road			
Map ID	Issue	Recommendation	Timeframe ⁴
4	<p>High Motor Vehicle Speeds and Missing Sidewalk – The speed limit on Fuller Heights Road is 35 mph. Research suggests that the odds of a pedestrian fatality resulting from a crash involving a pedestrian and a motor vehicle are nearly three times higher at 35 mph than at 25 mph for the average person.⁵ In November 2017, an adult pedestrian was killed while crossing Fuller Heights Road near St. Francis of Assisi Catholic Church. In addition, there are three apartment complexes (Virginian Apartments, Quantico Court Apartments, Quantico Terrace Apartments) and 16 single family homes on the southwest side of Fuller Heights Road along this segment. Triangle Elementary is on the east side of Fuller Heights Road, along with a number of other pedestrian destinations, including Fuller Heights Park, the St. Francis of Assisi School, and the Star Bethlehem Christian Academy. Existing marked crosswalks are uncontrolled, and the sidewalk is not continuous on both sides of the road, requiring a person walking along Fuller Heights Road to cross from side to side.</p> <p>Figures 14-19 show conditions along this segment.</p>	<p>In the medium term, reduce the speed limit along this segment to 25 mph. In the long-term provide continuous sidewalks with ADA compliant curb ramps at marked and unmarked crosswalk locations on both sides of the street.</p>	Short, Long

Fuller Heights Road at the St. Francis of Assisi Catholic Church and School Entrance Drive			
Map ID	Issue	Recommendation	Timeframe ⁶
5	<p>Difficult Crossing - This is currently the closest marked crossing of Fuller Heights Road to Triangle Elementary. It is necessary for pedestrians walking on the west side of Fuller Heights Road who wish to walk on a sidewalk to cross at this location, because the sidewalk on the west side ends south of the crosswalk but continues on the east side of Fuller Heights Road. The existing crosswalk is not a high-visibility crosswalk. Pedestrian crossing signage is posted on both sides, but the sign on the east side lacks a downward pointing arrow.</p> <p>Figures 14-17 show conditions at this intersection.</p>	<p>Remark the crosswalk as a high-visibility crosswalk. Add rectangular rapid flashing beacon and downward pointing arrow (W16-7p) to the pedestrian crossing sign on the east side of the road.</p>	Medium

Fuller Heights Road at the Fuller Heights Park Entrance Drive			
Map ID	Issue	Recommendation	Timeframe
6	<p>Difficult Crossing – This crossing provides access between the Virginian Apartments and Fuller Heights Park. It is also an important crossing for pedestrians walking on the northeast side of Fuller Heights Road, who must cross to the southwest if they wish to continue on the sidewalk.</p> <p>Figures 18 and 19 show conditions at this intersection.</p>	<p>Install rectangular rapid flashing beacon. Consider curb radius reduction on northwest corner.</p>	Medium

Lions Field Road between Highland Park Drive and Thomasson Crossing Drive			
Map ID	Issue	Recommendation	Timeframe ⁷
7	<p>Missing Sidewalk. There is no sidewalk on the northwest side of the street. A student accessing the school from the north via Thomasson Crossing Drive and Lions Field Road must cross Lions Field Road at Thomasson Drive rather than at Highland Park, where there is a crossing guard.</p> <p>Figures 11 shows conditions along this segment.</p>	Construct a sidewalk on the northwest side of the street.	Long

Intersection of Lions Field Road and Thomasson Crossing Drive			
Map ID	Issue	Recommendation	Timeframe
8	<p>Difficult Crossing. The crossings at this intersection are relatively long (over 50 feet) and there are no marked crosswalks. Students accessing the school from the north must cross Lions Field Road at this intersection because there is no sidewalk on the northwest side of Lions Field Road between Thomasson Crossing Drive and Highland Park Drive.</p> <p>Figures 20 shows conditions along this segment.</p>	In the short-term, install marked crosswalks on all three legs of this intersection and update curb ramps to comply with ADA. In the long-term, consider curb extensions to reduce pedestrian crossing distance.	Short, Long

Thomasson Crossing Drive between Hundred Acre Lane and Kerill road			
Map ID	Issue	Recommendation	Timeframe ⁸
9	<p>Missing Sidewalk. There is a partial sidewalk on the northeast side of the street that connects to Hundred Acre Lane but stops approximately 200 feet short of Lions Field Road. There are 29 houses on the northeast side of Thomasson Crossing Drive along this segment. Installing a sidewalk along this segment would improve pedestrian access for the students who live in these houses.</p> <p>Figures 20 shows conditions along this segment.</p>	Complete the sidewalk on the northeast side of the street.	Long

Easement between White Oak Drive, Sapling Way, and Triangle Elementary			
Map ID	Issue	Recommendation	Timeframe
10	<p>Poor Pedestrian Network Connectivity – Pedestrian network connectivity in the neighborhood surrounding Triangle Elementary is poor. Students who live very close to the school geographically must nevertheless walk long distances to get to the school due to the way that the roadway network is laid out. There may be opportunities to improve the connectivity of the pedestrian network by taking advantage of easements between properties. One such easement connects the northern end of White Oak Drive to Sapling Way. Another such easement appears to be a utility maintenance road and connects Sapling Way to the school property.</p>	<p>In the short-term, work with the Prince William County to identify easements near Triangle Elementary that might be used to improve pedestrian and bicycle access to the school.</p> <p>In the medium-term, construct a pedestrian/bicycle path connection between the northern end of White Oak Drive and Sapling Way. Also construct a path connection between Sapling Way and the school property.</p>	Short, Medium

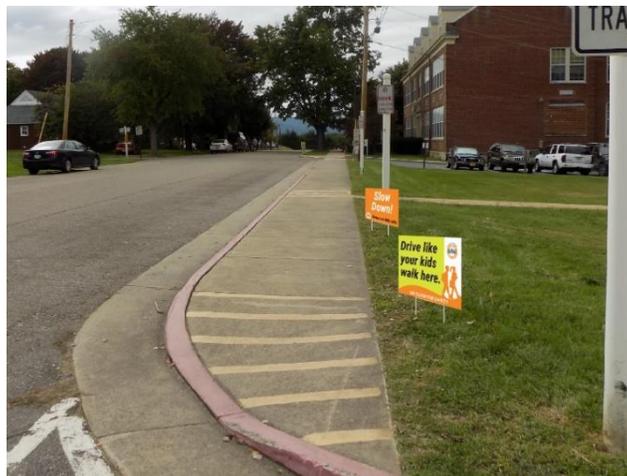
Figure 5: Zone In, Not Out Signage Example

Implement the Zone In, Not Out school zone safety program on Lionsfield Road. This program is aimed at increasing driver awareness of pedestrian and bicycle safety issues in school zones, and might help address the illegal parking and speeding concerns on Lionsfield Road. Resources are available on the Virginia SRTS website:

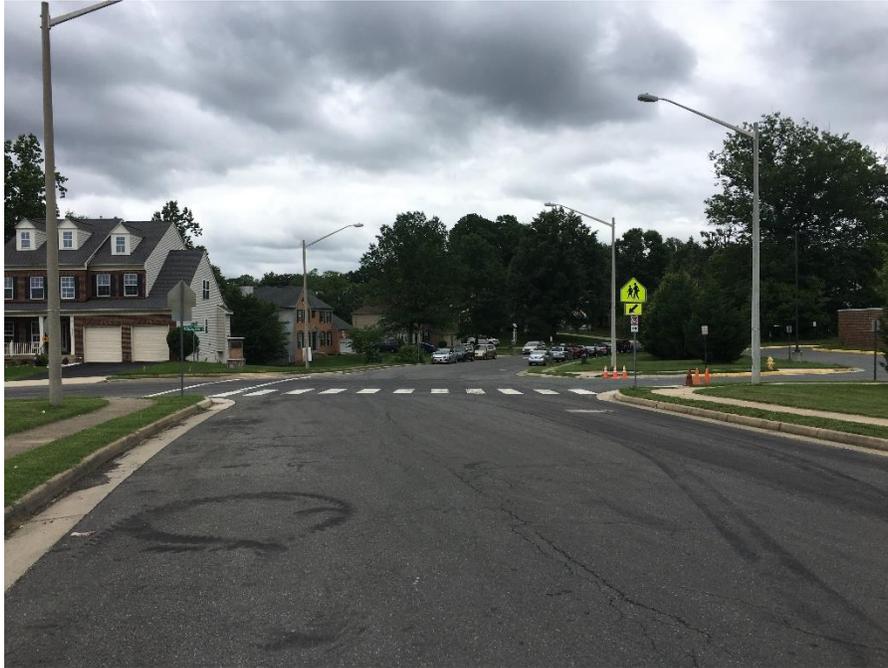
Figure 10: Lionsfield Road approaching Highland Park Drive from the south

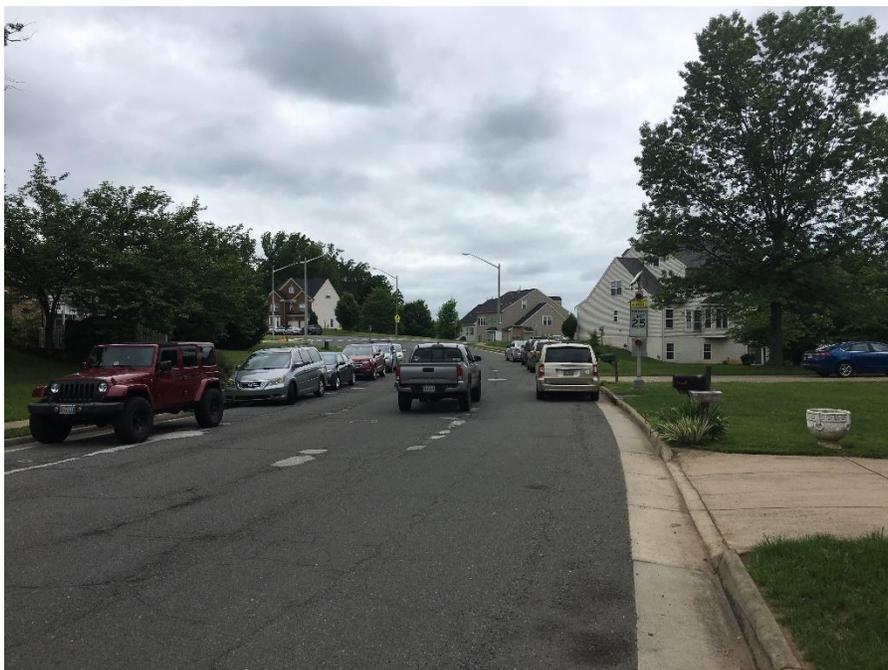
Figure 11: Lions Field Road approaching Highland Park Drive from north

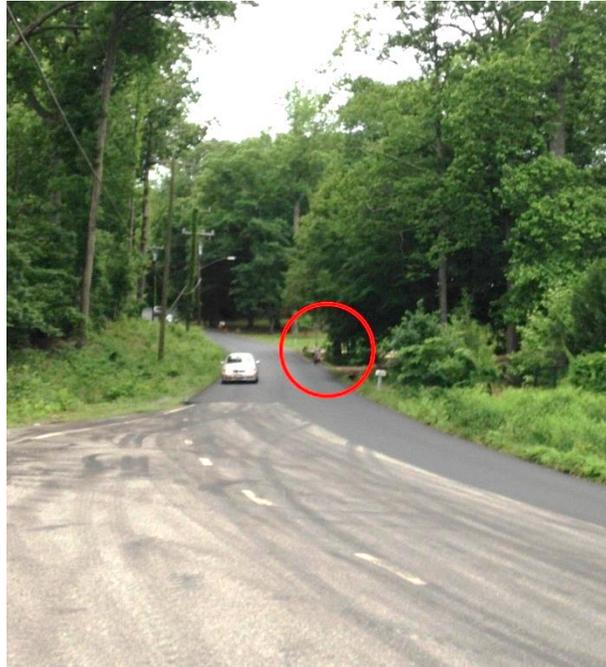
Figure 12: Woman and three children walk up Lions Field Road after school

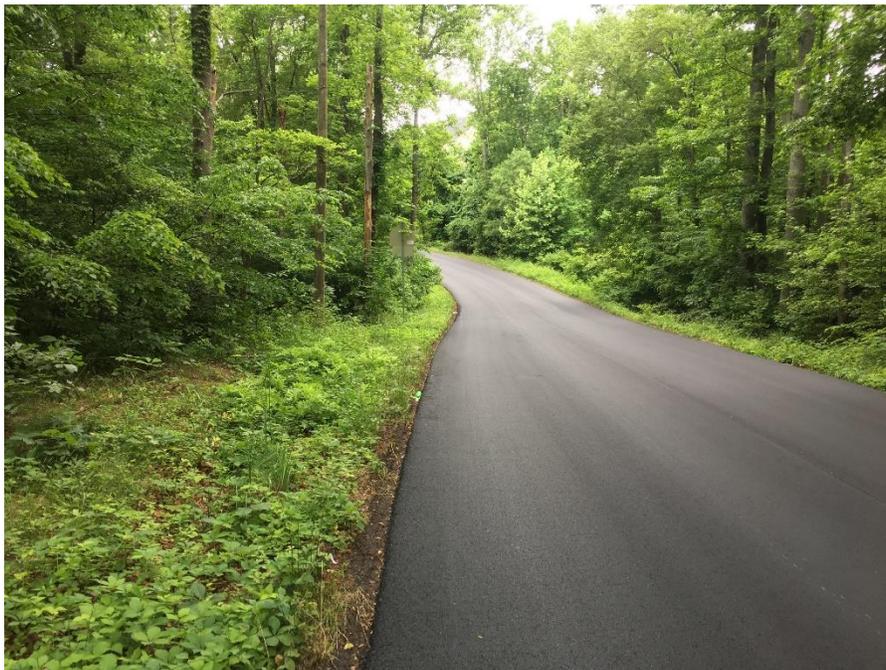
Figure 13: View of Lions Field Road south of school. Note the lack of shoulder and poor sight lines

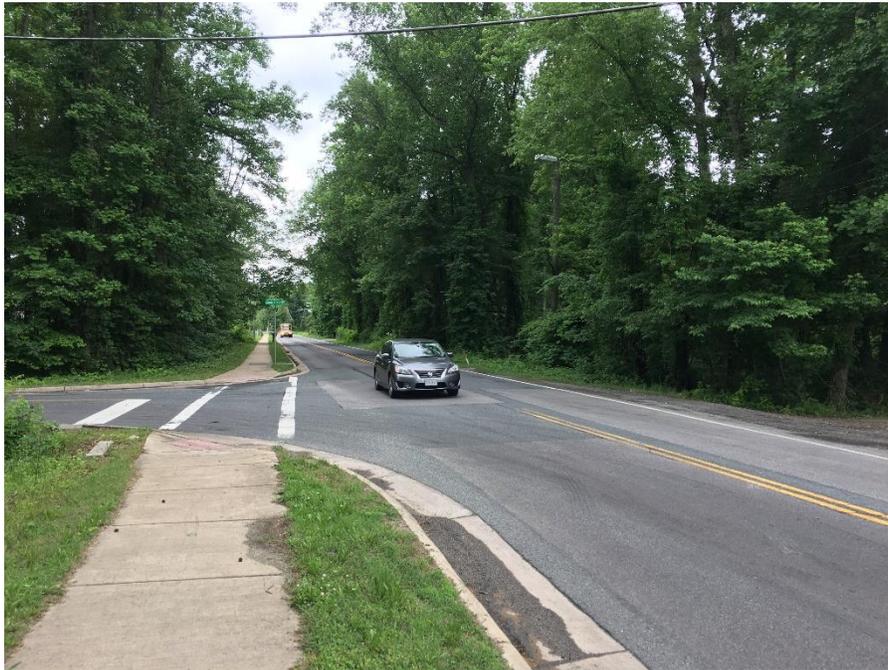
Figure 14: Intersection of Lionsfield Road and Fuller Heights Road (looking east)

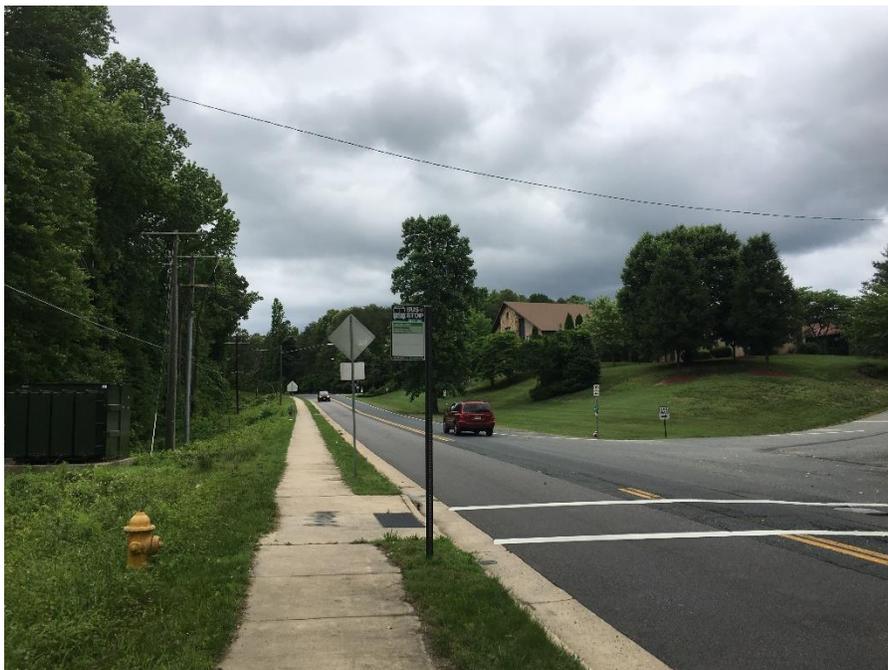
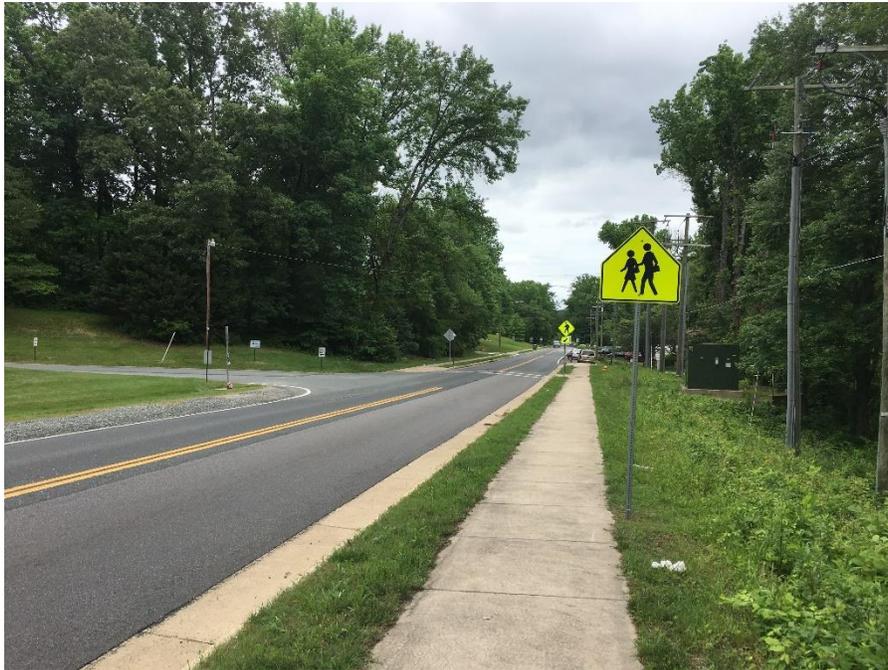
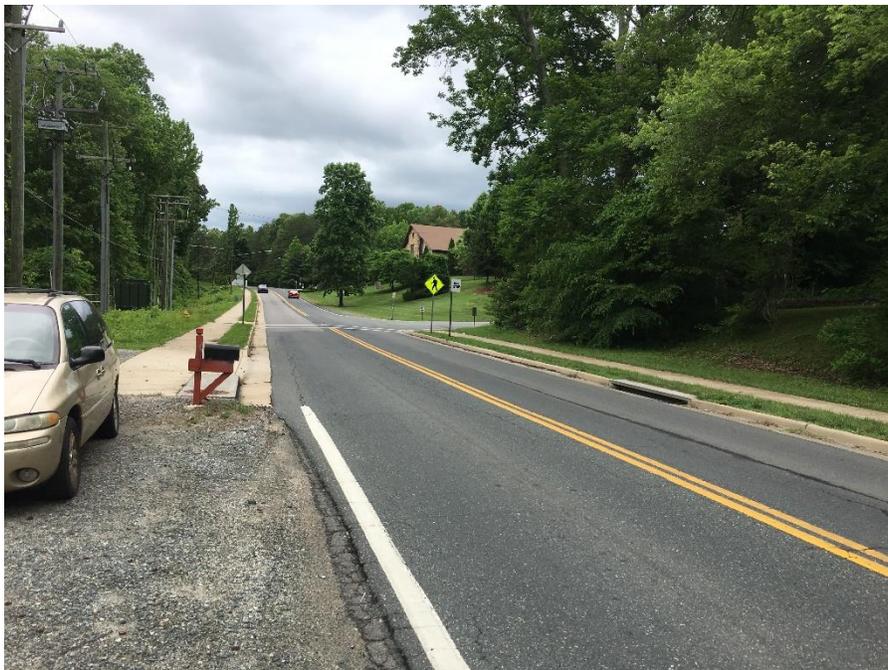
Figure 15: Intersection of Fuller Heights Road and St. Francis of Assisi Catholic Church entrance drive (looking west)

Figure 16: Intersection of Fuller Heights Road and St. Francis of Assisi Catholic Church entrance driveway (looking east)

Figure 17: Intersection of Fuller Heights Road and St. Francis of Assisi Catholic Church entrance driveway (looking west)

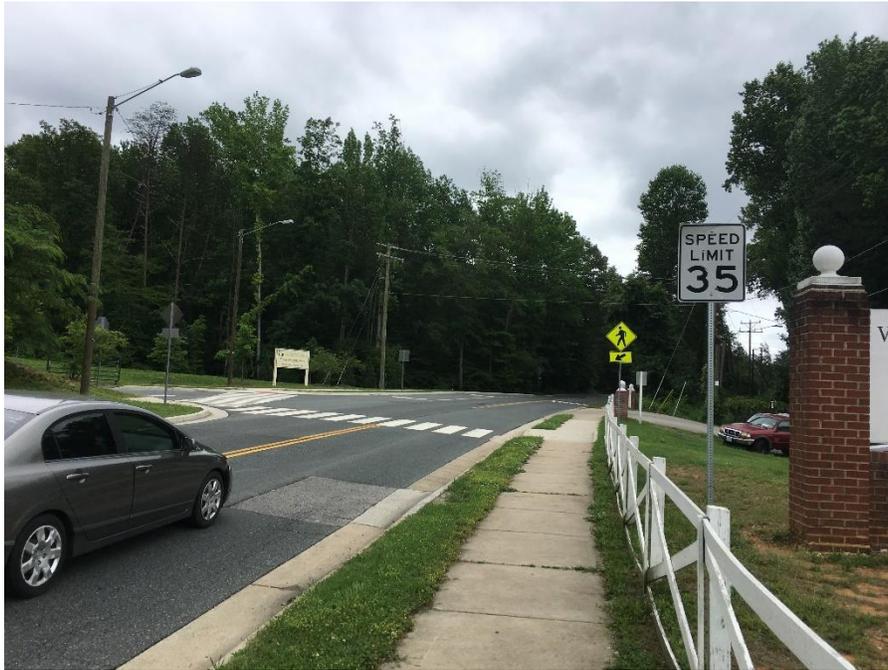
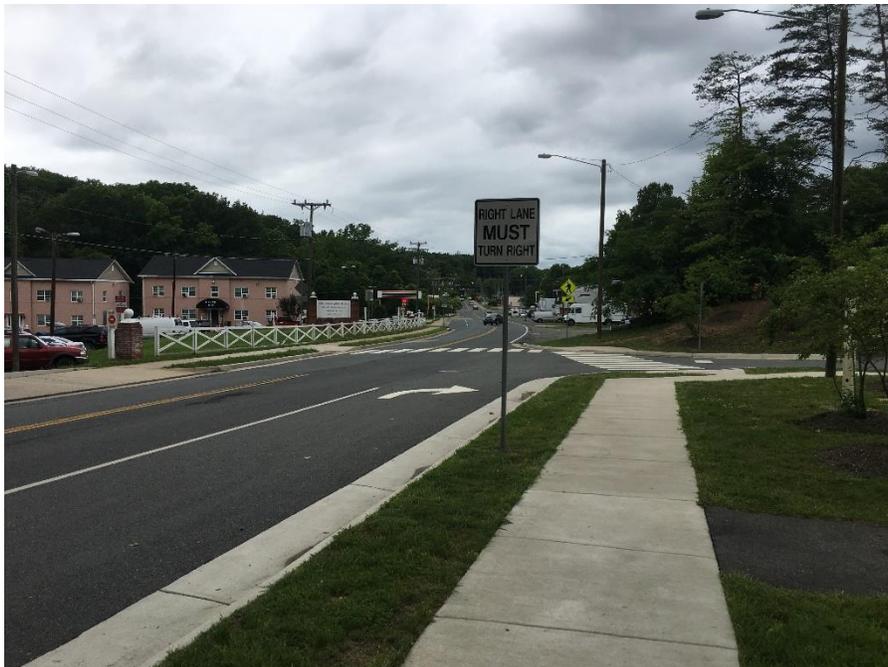
Figure 18: Intersection of Fuller Heights Road and Fuller Heights Park entrance driveway (looking east)

Figure 19: Intersection of Fuller Heights Road and Fuller Heights Park entrance driveway (looking west)

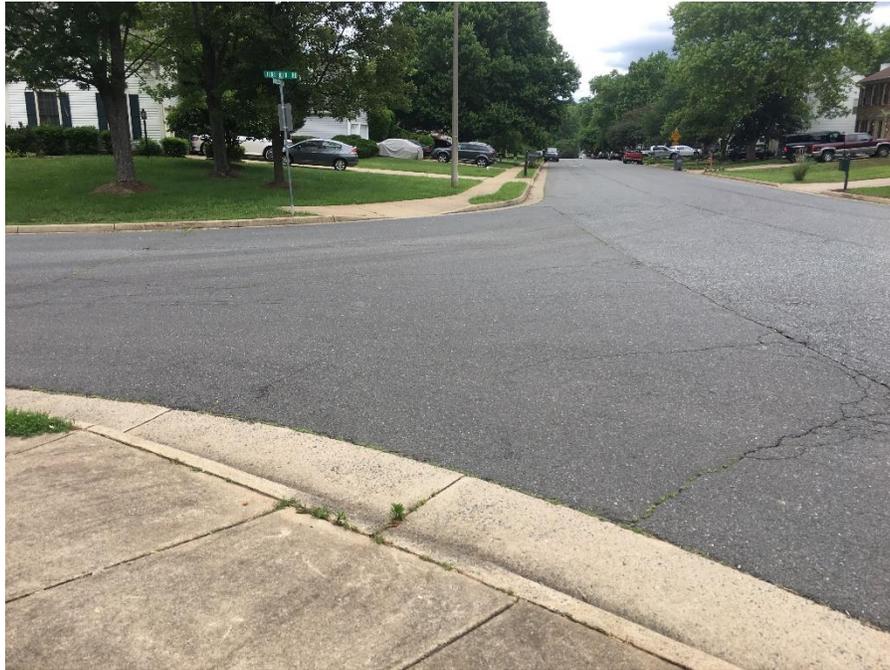
Figure 20: Intersection of Lions Field Road and Thomasson Crossing Drive
