Enhanced Walkabout Summary Report

Introduction

On September 26, 2013, 10 stakeholders at Glebe Elementary School (Glebe ES) in Arlington, Virginia met to examine the walking and bicycling network around the school and identify potential improvements to include in a Transportation Alternatives Program grant. The stakeholders included:

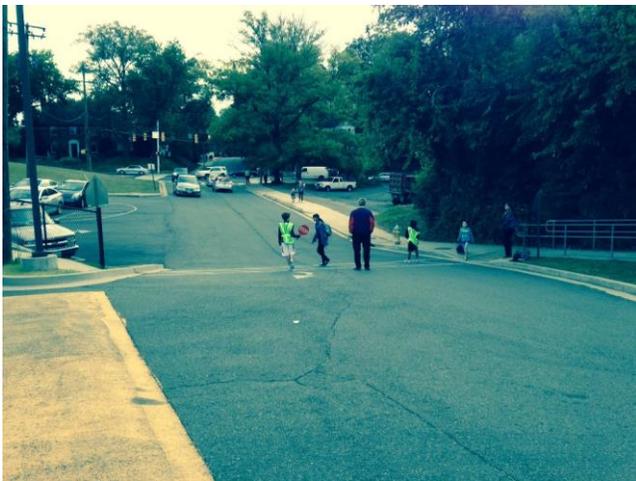
Figure 1 Members of the Glebe ES Student Safety Patrol also assist students crossing the school access drive.

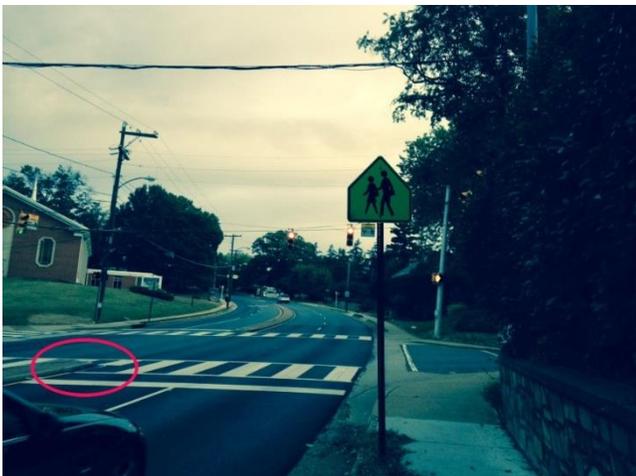
- *Concrete median.* The concrete median on N. Glebe Road extends into the crosswalk, forcing some pedestrians, such as those with strollers and mobility impairments, out of the crosswalk and into oncoming traffic to navigate around the median nose (Figure 2).

Figure 2 The concrete median on N. Glebe Road extends into the crosswalk, forcing some pedestrians, such as those with strollers and mobility impairments, out of the crosswalk and into oncoming traffic to navigate around the median nose.

- Constructing a sidewalk, curb, and retaining wall on the south side of 18th Street N. between N. Glebe Road and N. Wakefield Street.
- Reconstructing the curb ramps at the N. Glebe Road and 18th Street N. intersection.
- Adding an exclusive right-turn lane at the exit to the school access drive.
- Closing the curb cuts on the south side of the school access drive.
- Adding school crossing warning signage, marked crosswalks, and ADA compliant curb ramps at 18th Street N. and N. Wakefield Street intersection.

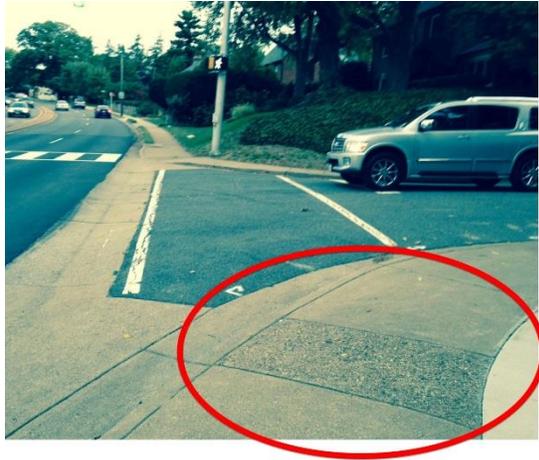
- *Curb ramps.* A single curb ramps serves each corner instead of the preferred one curb ramp per crossing. As a result, the curb ramps are oriented at a diagonal to the crosswalk, forcing pedestrians into motor vehicle travel lanes (i.e., oncoming traffic). The curb ramps also do not meet current ADA guidelines, which require truncated dome detectable warnings (Figure 3).
- *Signal timing.* The intersection is signalized; however, the signal does not provide enough time during school arrival and dismissal times for motor vehicles to exit the school access drive onto N. Glebe Road. Consequently, there are often significant back-ups along the school access drive (Figure 4). The signal is maintained and operated by Arlington County.

Figure 3 A single curb ramps serves each corner instead of the preferred one curb ramp per crossing. As a result, the curb ramps are oriented at a diagonal to the crosswalk, forcing pedestrians into motor vehicle travel lanes (i.e., oncoming traffic). The curb ramps also do not meet current ADA guidelines, which require truncated dome detectable warnings.

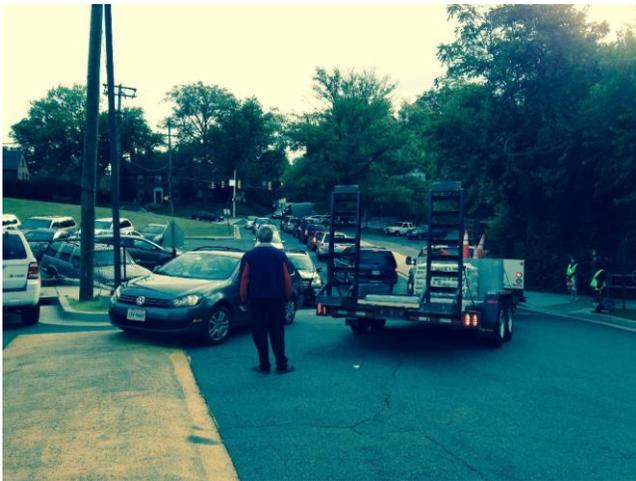
Figure 4 There are often significant back-ups along the school access drive due, in part, to the way the signal is timed at the N. Glebe Road intersection.

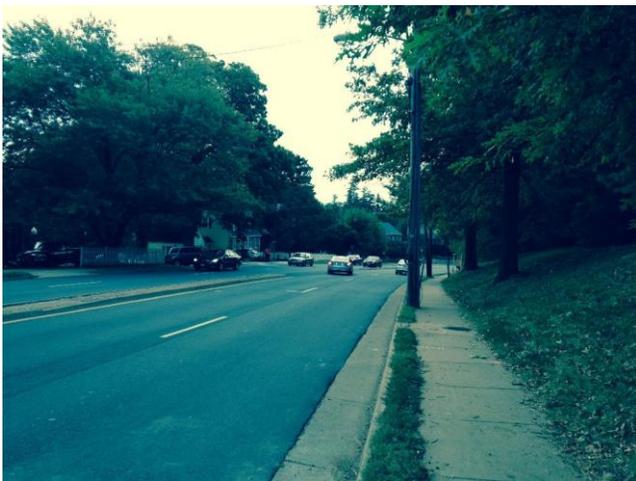
- *Sidewalks.* The sidewalks on N. Glebe Road are approximately 5 ft. wide; however, utilities and vegetation narrow the clear width of the sidewalk to less than 5 ft. at multiple locations near the school.

- *Buffer between pedestrians and motor vehicle traffic.* N. Glebe Road lacks bicycle lanes, shoulder edge lines, and on-street parking to buffer pedestrians from traffic. A landscaped buffer is provided along much of the roadway in the vicinity of the school; however, it is relatively narrow (1-3 ft. wide), and motor vehicle traffic tends to drive close to the curb due to relatively narrow outside travel lanes (11 ft. wide) (Figure 5).

Figure 5 The sidewalks on N. Glebe Road are approximately 5 ft. wide; however, utilities and vegetation narrow the clear width of the sidewalk to less than 5 ft. at multiple locations near the school. N. Glebe Road lacks bicycle lanes, shoulder edge lines, and on-street parking to buffer pedestrians from traffic. A landscaped buffer is provided along much of the roadway in the vicinity of the school; however, it is relatively narrow (1-3 ft. wide), and motor vehicle traffic tends to drive close to the curb due to relatively narrow outside travel lanes (11 ft. wide)

- N. Glebe Road between N. Woodstock Street and 17th Street N. To widen the buffer between pedestrians and moving vehicles, slow motor vehicle traffic, and increase awareness of the school zone.
 - Restripe the roadway with 10-ft-wide travel lanes and edge lines.
 - Move the school zone speed limit sign and flashing beacon on the west side of N. Glebe Road north to coincide with the advanced traffic control sign at 20th St.
- 18th Street N. and Wakefield Street intersection. To improve sightlines between pedestrians and motor vehicle drivers:
 - Expand the “no parking” zone on the intersection approaches.
- Glebe Campus Access. To improve campus pedestrian access:
 - Install a curb ramp on the north side of the school access drive crosswalk.
 - Investigate the potential to provide an accessible pedestrian pathway between Culpepper Street and 20th Street.

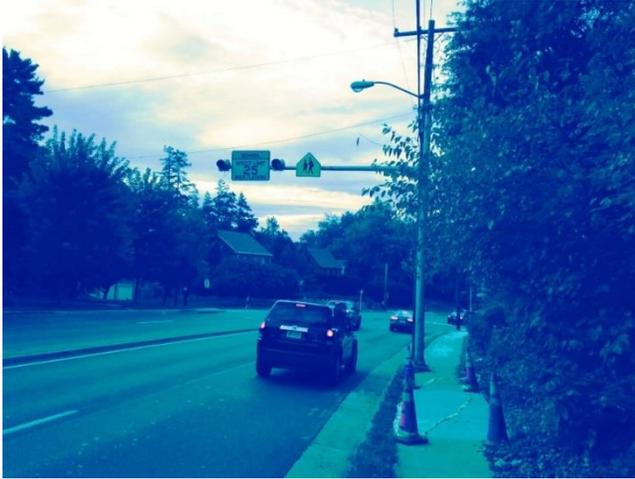
- *School zone speed limit sign and flashing beacon.* The school zone speed limit sign and flashing beacon for southbound traffic is located on a curve approximately 350 feet north of the 18th Street N. intersection. This location has limited visibility for motorists and may not provide motorists with sufficient warning of the upcoming school crossing (Figure 6).

Figure 6 The school zone speed limit sign and flashing beacon for southbound traffic is located on a curve approximately 350 feet north of the 18th Street N. intersection. This location has limited visibility for motorists and may not provide motorists with sufficient warning of the upcoming school crossing.

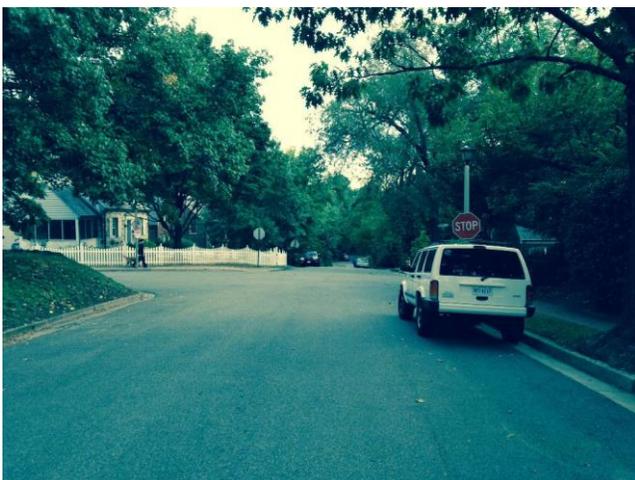
- *Sightlines between motorists and pedestrians at intersection.* The poor sightlines at the intersection are a consequence of topography—the intersection is at the crest of a hill—and cars parked too closely to the intersection, blocking both motorists' and pedestrians' views.

- *Crossing treatment.* None of the crosswalks is striped. Consequently, motorists may be less likely to anticipate pedestrians at this crossing (Figure 8).

Figure 8 At the intersection of 18th Street N. and N. Wakefield Street, none of the crosswalks is striped. Consequently, motorists may be less likely to anticipate pedestrians at this crossing. Also, vehicles sometimes park too close to the intersection, making it more difficult for pedestrians and motorists to see each other.

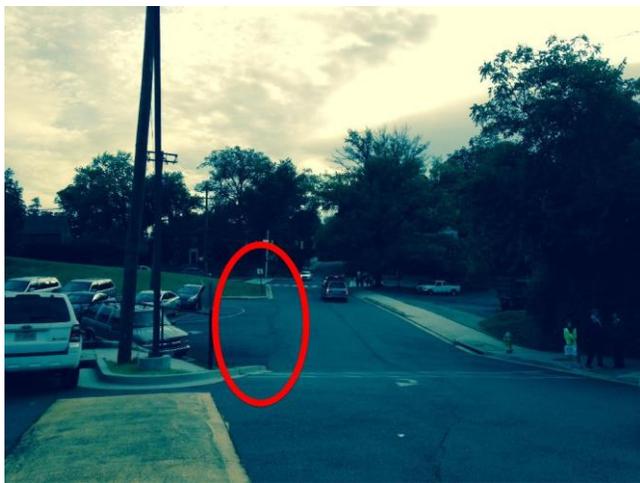
- *No sidewalk on church side of school access drive.* As a result, pedestrian must use the sidewalk on the south side of the school access drive and then crossover to the north side using the crosswalk at the entrance to the school parking lot. (Figure 9)

Figure 9 There is no sidewalk on the school side of the school access drive. As a result, pedestrian must use the sidewalk on the south side of the school access drive and then crossover to the north side using the crosswalk at the entrance to the school parking lot

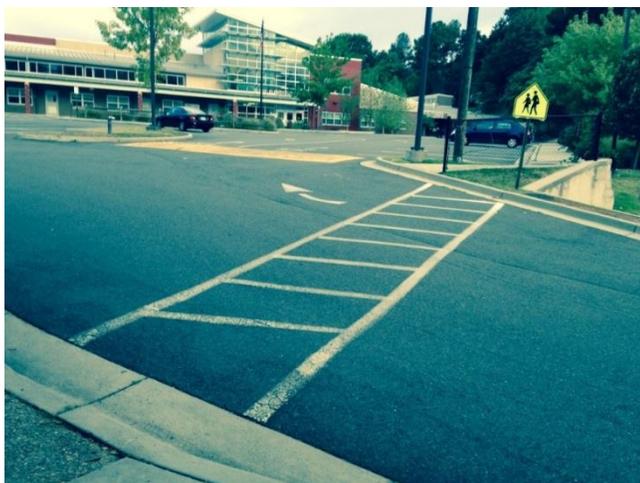
- *No accessible route on north side of school access drive crosswalk.* There is an accessible route from the south side of the school access drive but it is considerably longer. (Figure 10).

Figure 10 There is no curb ramp on the north side of the school access drive.

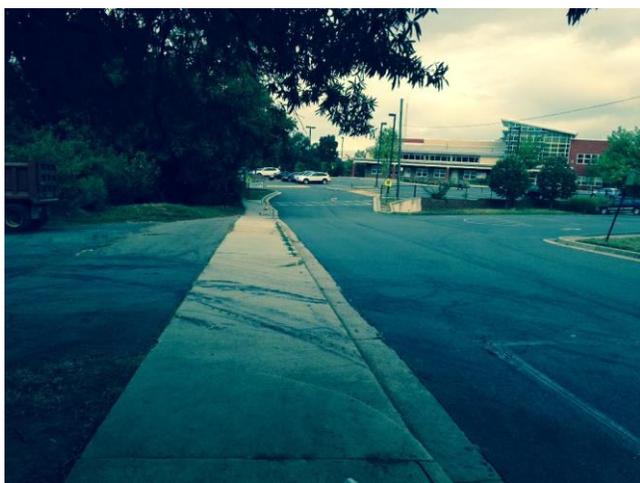
- *Curb cuts in school access drive sidewalk.* Some drivers attempt to avoid the backups when exiting onto N. Glebe Road by taking a short cut through the vacant lot on the southwest corner of the intersection. This maneuver is feasible due to wide curb cuts on the school access drive (Figure 11) and N. Glebe Road. In both cases, motorists cross sidewalks that are heavily used by student pedestrians during arrival and dismissal.

Figure 11 Curb cuts provide access to abandoned property, which drivers exiting Glebe ES sometimes use as a shortcut.

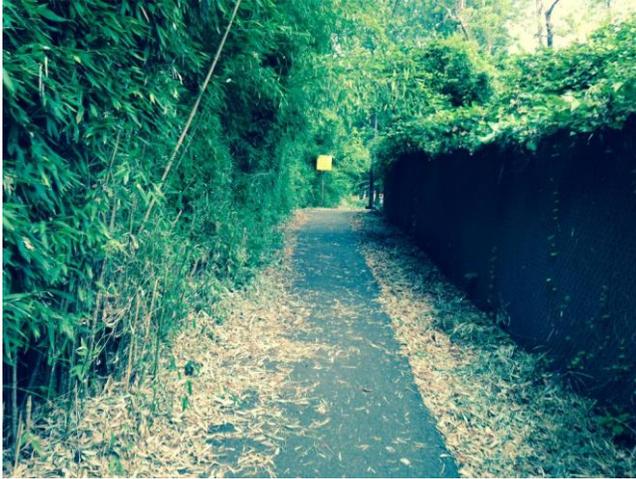
- *Off-campus pathway maintenance.* The off-campus path connection between Culpepper Street and the school property is not regularly swept and vegetation encroaches on the pathway's clear-width (Figure 12).

Figure 12 The pathway connection between Culpepper Street and the school property is covered with debris, and bushes narrow the path's clear width.

- Request that Arlington Police Department conduct additional speed enforcement on N. Glebe Road in the vicinity of the school.
- Regularly maintain on-campus pathways, including sweeping away debris.
- Regularly maintain off-campus pathways, including trimming foliage and sweeping away debris.
- Track participation in the Walk, Bike and Roll Program (and the BFF campaign) to determine the program’s impact on students.

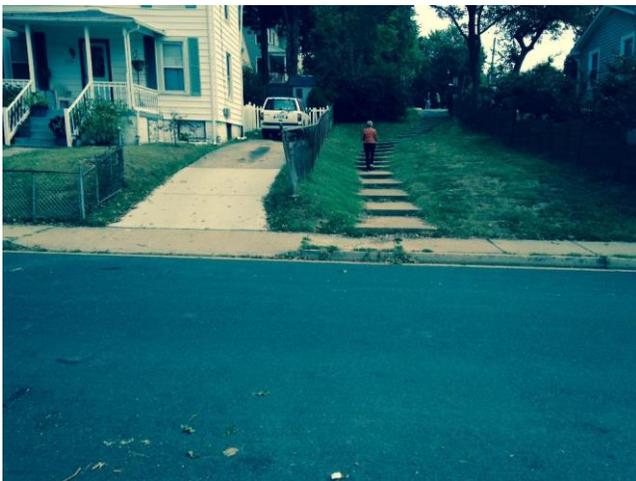
- *The off-campus path connection between Culpepper Street and 20th Street is not an accessible route because a portion of it includes shallow steps leading down to the street* (Figure 13).

Figure 13 The pathway connection between Culpepper Street and 20th Street is not accessible.

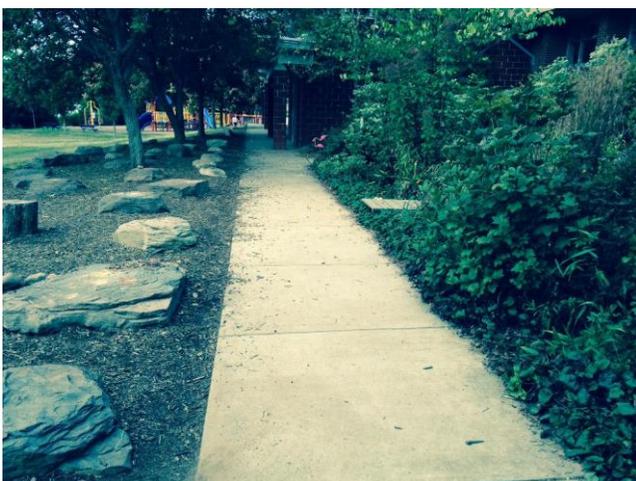
- *On-campus pathway maintenance.* On-campus walkways are not regularly swept (Figure 14).

Figure 14 Debris on a campus pathway.

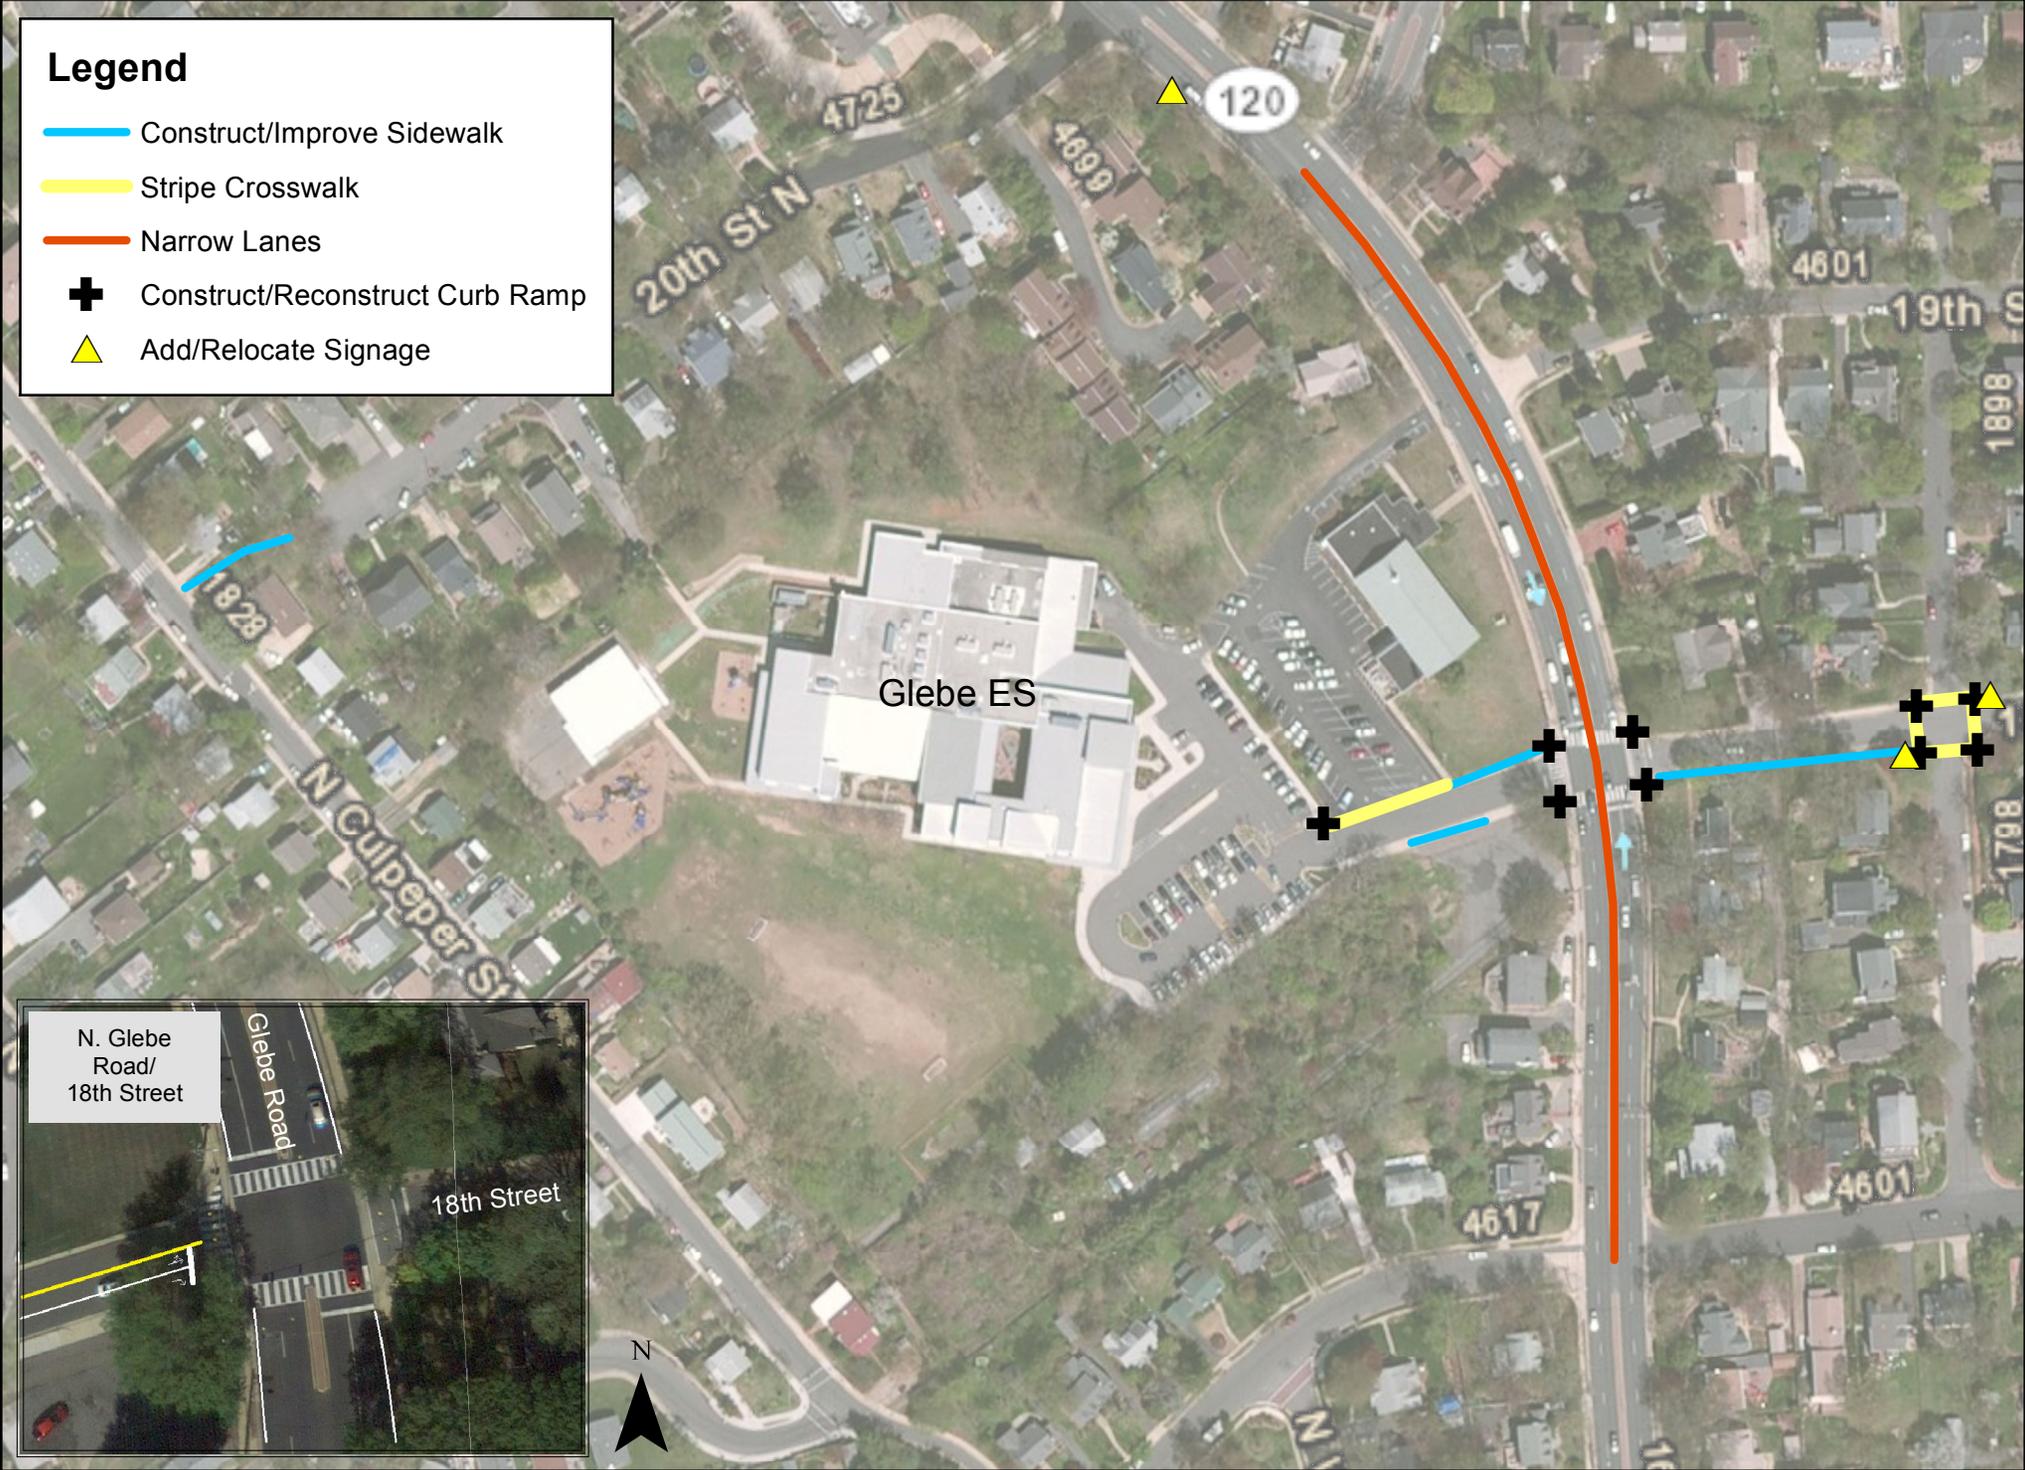
Glebe ES - Walkabout Recommendations

- Construct/Improve Sidewalk
- Stripe Crosswalk
- Narrow Lanes
- Construct/Reconstruct Curb Ramp
- Add/Relocate Signage
