EXISTING CONDITIONS 2011 – MAINLINE & RAMP ADTS I-95/I-64 Overlap Study
City of Richmond, Virginia

EXISTING CONDITIONS 2011 – RAMP ADTS I-95/I-64 Overlap Safety and Operations Study City of Richmond, Virginia

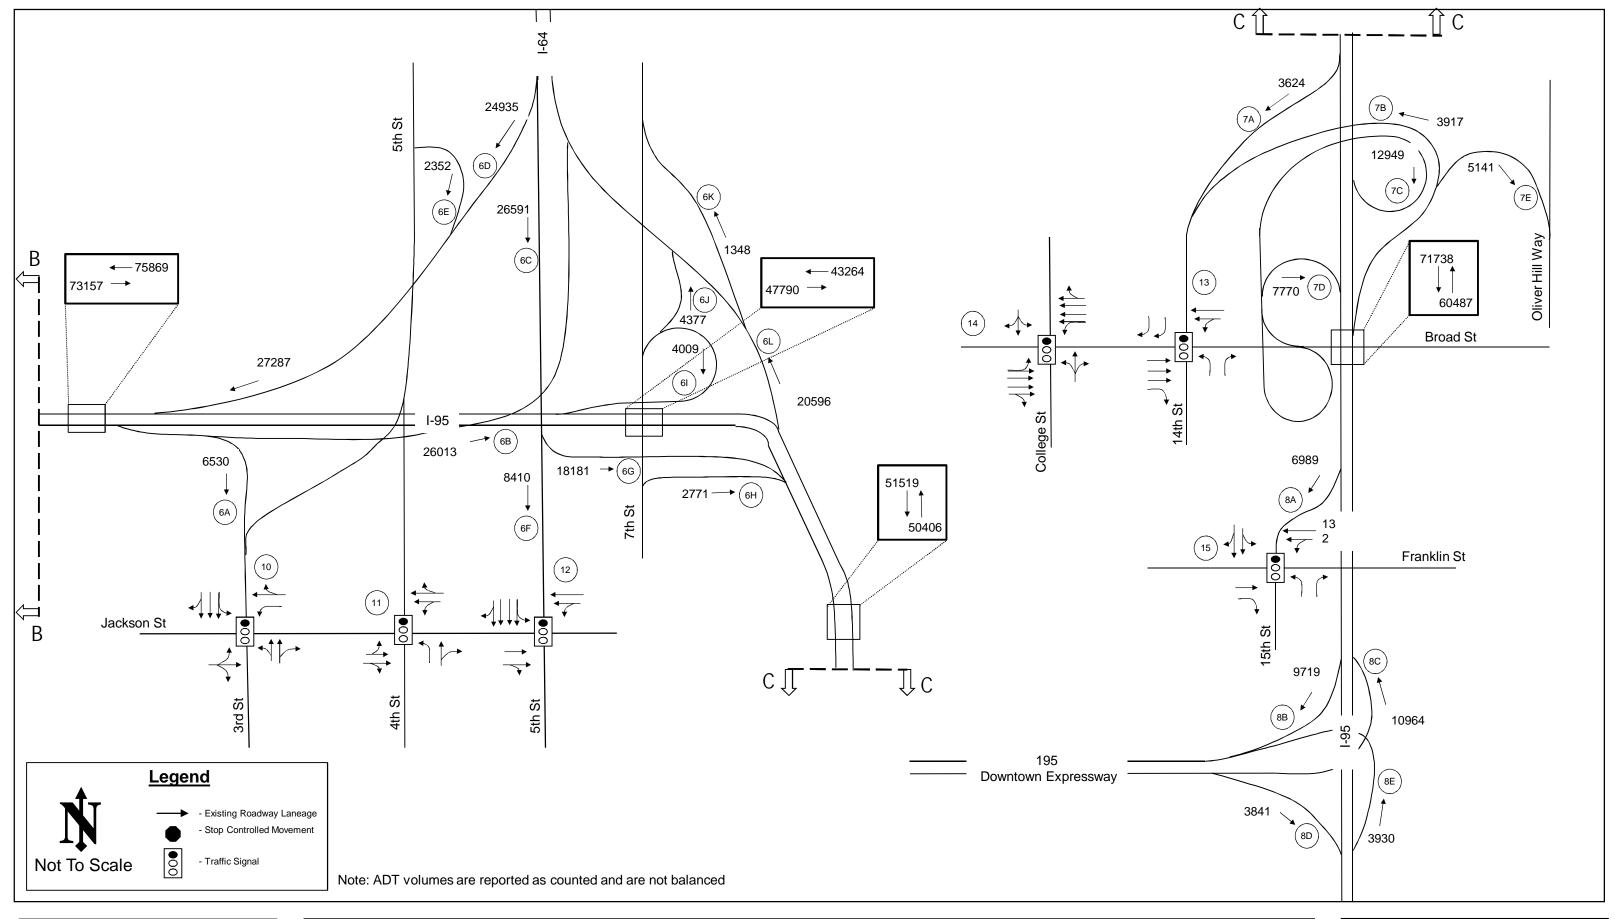
FIGURE D3

EXISTING CONDITIONS 2011 – RAMP ADTS I-95/I-64 Overlap Safety and Operations Study City of Richmond and Henrico County, Virginia
